**Citation:** Ivashko, Y., Ivashko, O., KUZMINA, H., DMYTRENKO, A., TWARDOWSKI, G., (2026). Features of the historical residential development of Kyiv Podil and modern problems of use, *Środowisko Mieszkaniowe/ Housing Environment*, 56, pp. 18–28, e2026010. <https://doi.org/10.2478/he-2026-0010>

# Features of the historical residential development of Kyiv Podil and modern problems of use

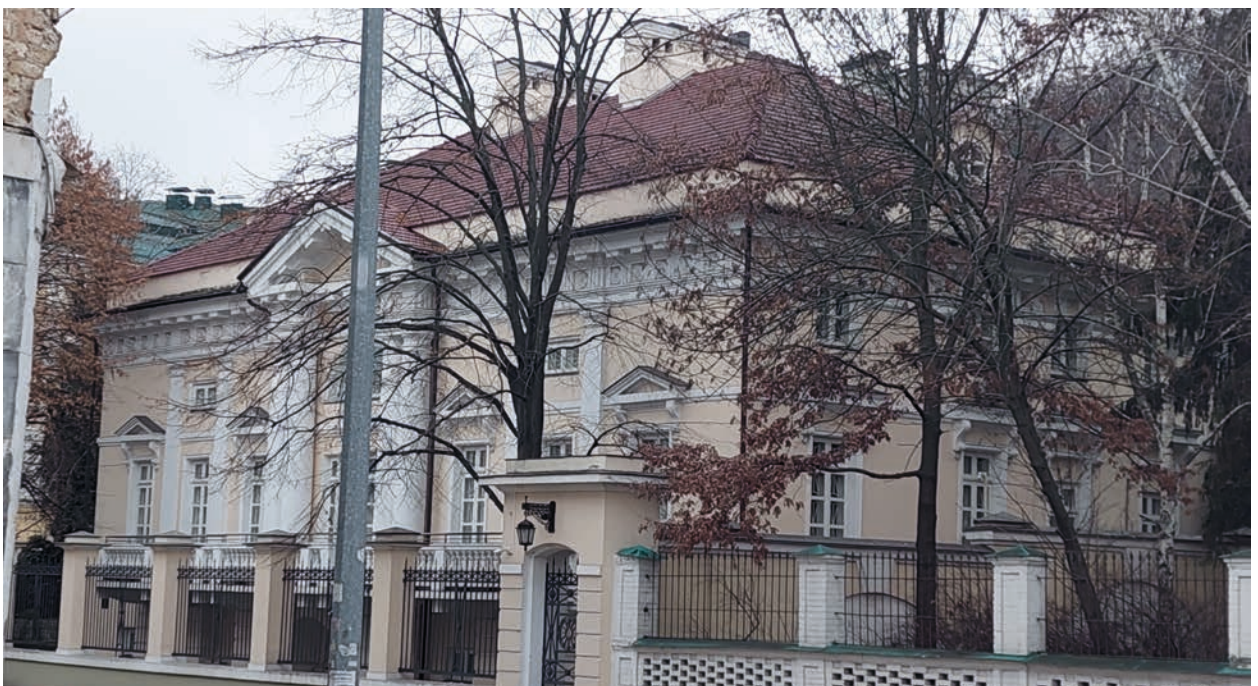
Among the few houses that survived the fire of 1811, one should mention house No. 5, which belonged to the jeweller Samson Strelbytskyi. This house was built in 1808 in the classicist style and is made of brick (III. 2).

III. 2. Samson Strelbytskyi's house. Photo by Y. Ivashko, December 21, 2025

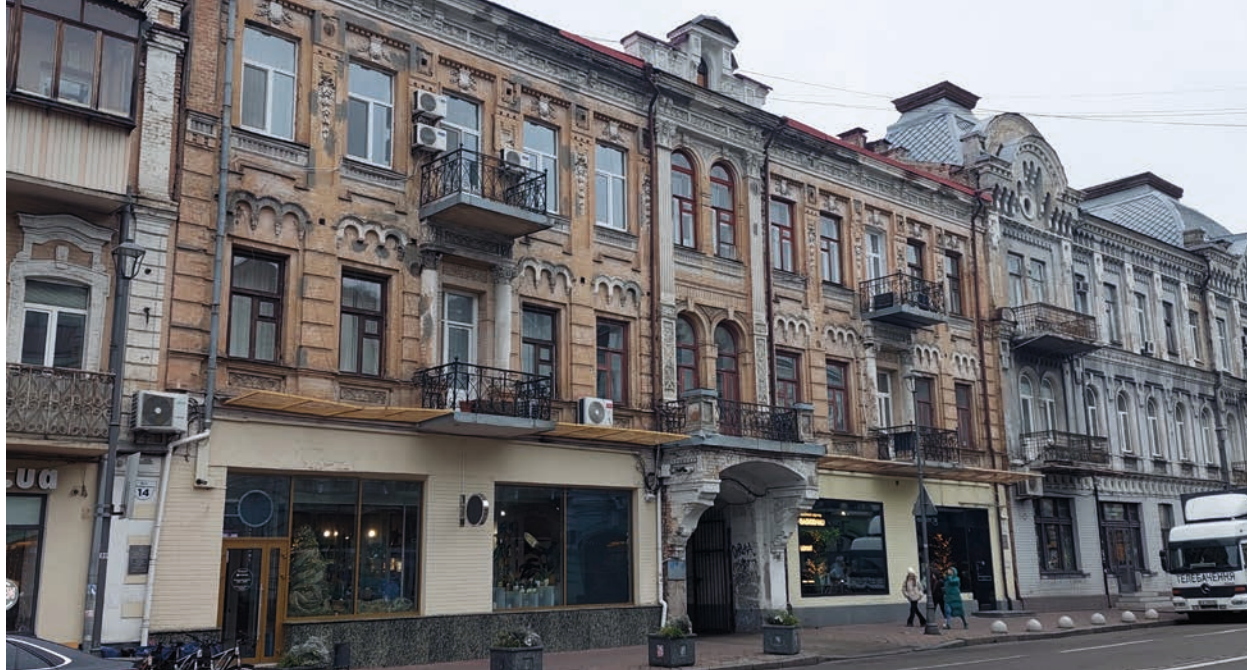
III. 3. Perspective of Petra Sahaidachnoho Street. Photo by Y. Ivashko, December 21, 2025

Many residential buildings on Oleksandrivska Street belong to the early period of the street's development. These are two- or three-story houses in the classicist style with simple facade decoration. However, the most common style of building on the street was historicism, with extensive stucco and brick decoration (III. 3).

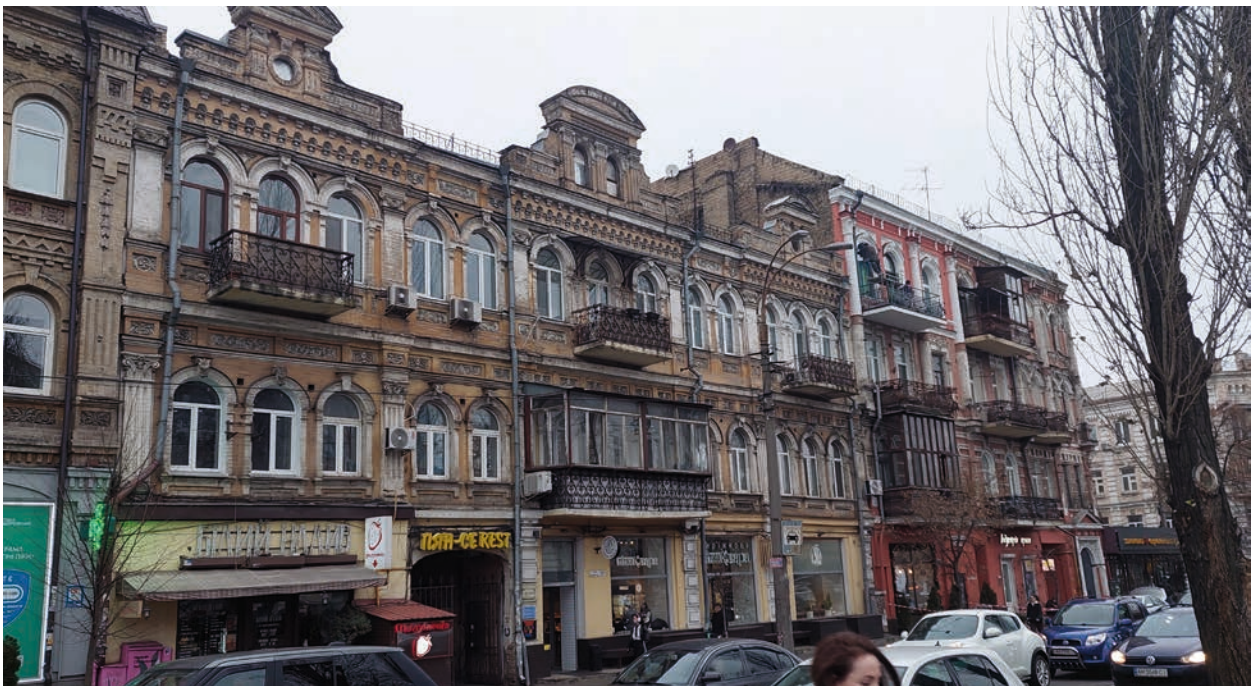
III. 4. Houses at 33 and 35 Nyzhniy Val Street. Photo by Y. Ivashko, December 21, 2025

House No. 33 is somewhat similar in architectural style to the neighbouring house No. 35 (III. 4). Both are designed in the historicist style, a pseudo-Renaissance style popular at the time among merchants and burghers. The owner of the estate No. 35 was the Kyiv merchant Ye. Zadolynnyi until 1857. At that time, a stone and wooden house, a brick outbuilding, and a barn were built on the estate. In 1857, the merchant Khoroshynskyi became the next owner of the estate. The new owner dismantled the old auxiliary buildings in the yard and built new ones in their place. As of 1897, the estate included a brick two-story residential building with a shop on the ground floor, a two-story stone-and-wooden residential building with a restaurant and shops on the ground floor, a two-story brick residential building with shops, a new wooden shop, a brick one-story wing, and office premises. Water and sewage were installed in the estate.

However, in house No. 35, a different compositional structure was used – the house is four stories tall; the ground floor is occupied by shops, and the upper floors by apartments. Unlike house No. 33, the main facade is asymmetrical; the shapes of the windows in the side parts are different – sometimes semi-circular, sometimes paired, sometimes rectangular. Pairs of columns separate the side parts and the central part to a height of 2nd–3rd floors on pedestals, at the level of the ground floor – pairs of pilasters. The ground floor imitates rustication, and the windows are framed.

| Address | Year of construction | Style | Functional use | | State of preservation and main conservation problems |
|---|---|---|---|---|---|
| 33 and 35 Nyzhnii Val Street | end of the 19th century | Historicism | Tenement houses with shops | Residential buildings with shops | Facade contamination, peeling paint on facades, no comprehensive restoration project, each owner installs their own windows |

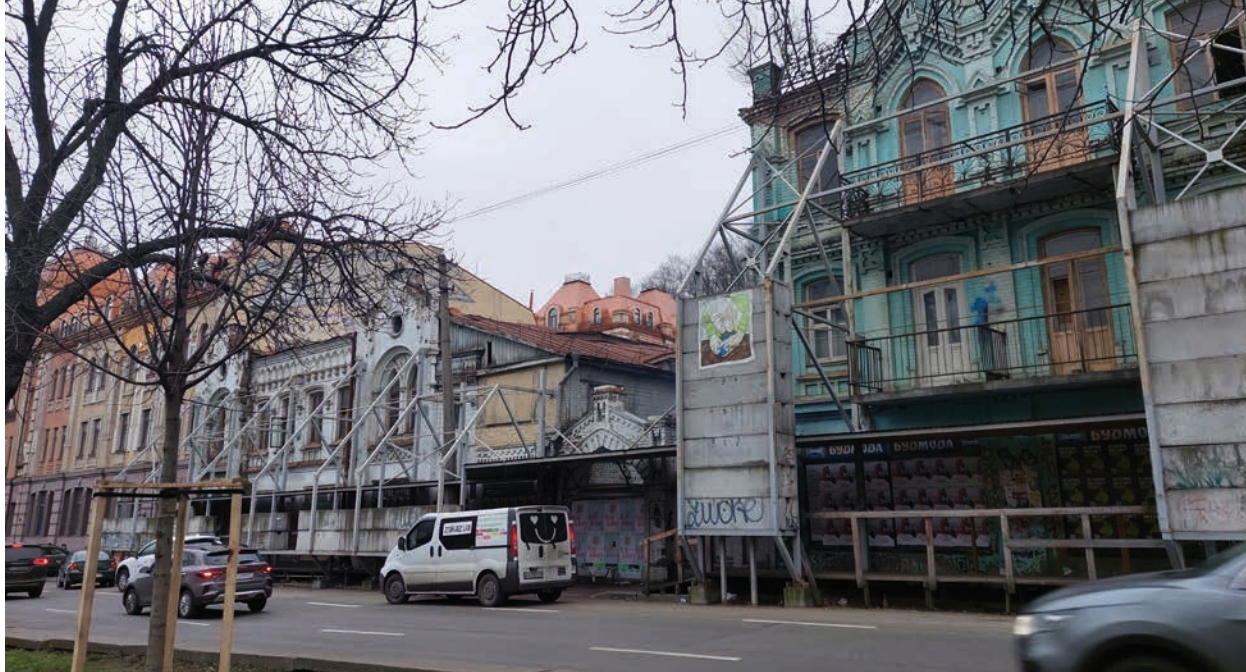
III. 5. Modern view of the Gothic-Revival manor house from the street. Photo by Y. Ivashko, December 21, 2025

On one of the central streets of Podil – Verkhniy Val, two houses differ from the others in their unusual Gothic-Revival appearance (Fig. 5). Once, both houses, with a gate between them, belonged to the Prussian subject K.-L. Nytskyi, who owned the estate from 1886 to 1915. The estate was a plot elongated along the street, on which houses and auxiliary buildings were built in 1893 and 1908. The Neo-Gothic style was maintained in the two main houses and the gate to the courtyard. It is believed that the author of the earlier two-story house of 1893 was K. Shyman. This is confirmed by the attraction of this extravagant architect to Gothic stylisation (in the buildings at 10 Malopidvalna Street and at 2-b and 2-c Andriivskyi Descent). He was also involved in approving the project in the Kyiv City Council and supervising the author.

The two-story Gothic-Revival house was built on the site of dismantled wooden buildings. It is a brick building with traditional shops on the ground floor, including a sausage shop. The composition of the main facade is two-axis; the axes pass through two entrances, windows, and decorative pinnacles with side turrets. Despite the general Neo-Gothic style, there is a layering of other styles – Gothic windows are combined with round, bow, and rectangular. The neighbouring later house was designed in a similar style; on the upper floors, there were four windows, on the lower – shop windows. In the centre of the first and second floors were two wide balconies with openwork metal railings.

| Address | Year of construction | Style | Functional use | | State of preservation and main conservation problems |
|---|---|---|---|---|---|
| 33 and 35 Verkhnii Val Street | 1893 | Gothic Revival | Sausage factory with shop and habitable rooms | Residents are now being evacuated due to the state of emergency | Violation of the statics of buildings due to multi-storey complexes nearby, tilting of facades with the threat of collapse, cracks, waterlogging of foundations and roofs, biofouling |
