NUMERICAL MODELLING OF COUPLED HEAT AND WATER TRANSPORT ON EMBANKMENT DAM IN KOZLOWA GORA

Abstract

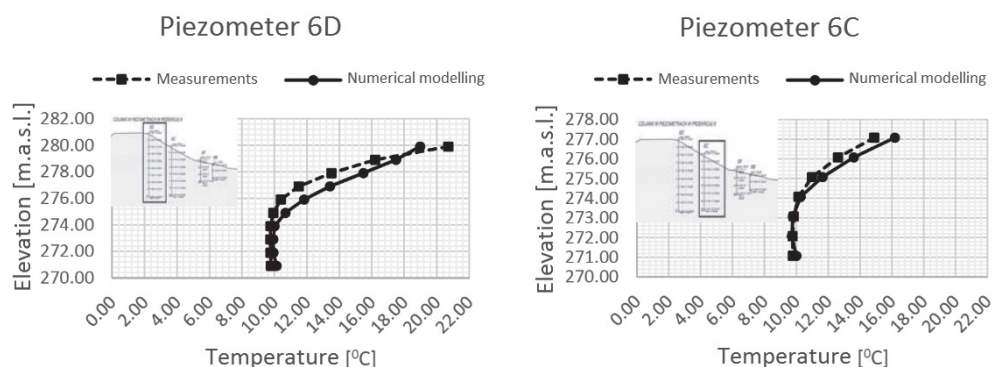
the best correlation was sought of the modelled piezometric level and, in particular, of the modelled vertical thermal profiles measured in piezometers for cross-section 6 in the analyzed period, with actual measurements. Fig. 4 shows a comparison of the actual and modelled temperatures in the vertical profiles in piezometers 6C and 6D. The mean error between the data obtained from thermal monitoring and modelling amounted to 0.66°C for piezometer 6D and 0.46°C for piezometer 6C. The maximum error for piezometric pressures was 0.18 m for piezometer 6D and 0.10 m for piezometer 6C. Finally, the modelling allowed to determine the permeability coefficient for the foundation as 1e-5 m-1s, and the seepage window opening under the sheet piles as 0.3 m.

Fig. 4. Vertical thermal profiles in piezometers 6D and 6C for data obtained from the numerical model and data from thermal monitoring of the Kozłowa Góra dam on 30 June 2014

The obtained data do not completely rule out the occurrence of suffosion erosion processes in the dam foundation, but they ruled out the existence of severe erosion or a zone of particularly privileged flow and locally severe erosion. Hypothetical impact of the emergence of such a zone on temperature measurements is presented in section 6.

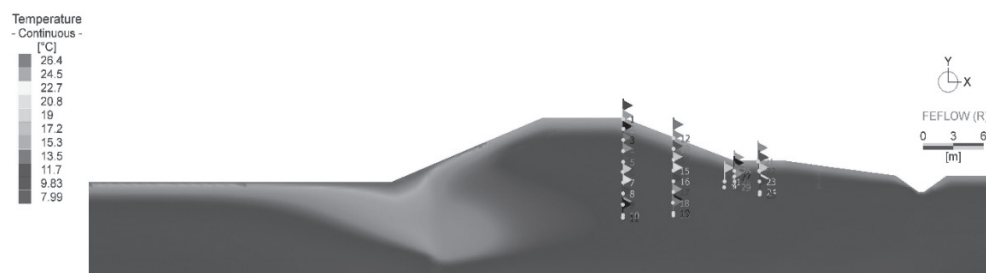
Fig. 5. Thermal field of Kozłowa Góra dam cross-section 6-6 modelled for 30 June 2014

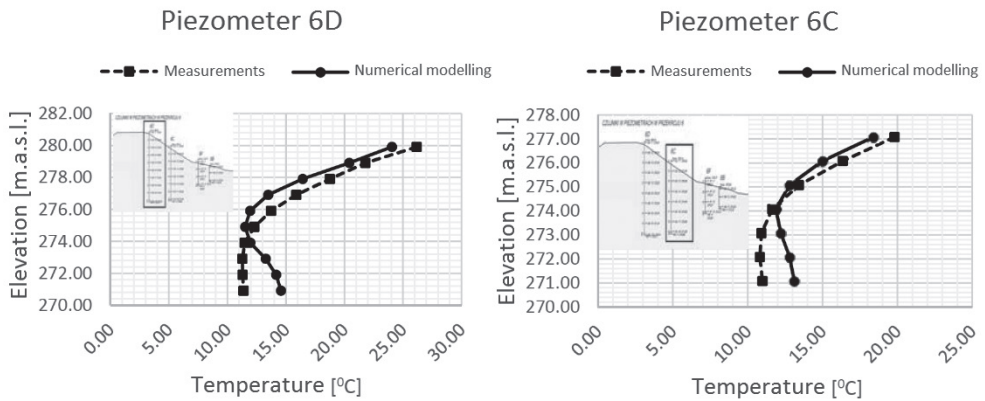
This section describes the hypothetical impact of a privileged flow zone with deteriorated soil parameters on the temperature field in cross-section 6-6, if such a zone existed in the foundation. In relation to the calibrated numerical model described in section 5, the permeability coefficient in the foundation was increased by an order of magnitude, i.e. to k = 1e-4 m-1s. There was a seepage opening between sheet piles and impermeable tertiary foundation layer as in the previous case. Fig. 6 shows the modelled vertical temperature profiles in piezometers 6C and 6DZ with actual measurements. A significant increase in the difference between modeled and the actual temperatures is evident from elevation of 275.50 m OSL downwards, increasing with depth in relation to the results

Fig. 6. Thermal profiles in piezometers 6D and 6C for data obtained from the numerical model and data from thermal monitoring of the Kozłowa Góra dam on 4 August 2014

shown in Fig. 4. Such a thermal anomaly would result from the modelled, hypothetical zone of privileged flow, and consequently the increased advective heat transfer towards the downstream side.

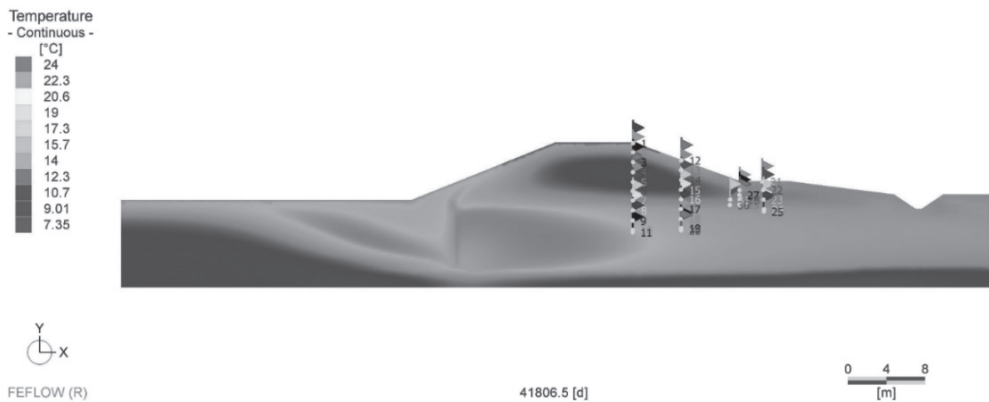
Fig. 7. Thermal field of Kozłowa Góra dam cross-section 6-6 modelled for 4 August 2014
