BARBARA MARIA DEJA\*

## RENOVATION OF THE HISTORIC OLSZTYN VILLA CASABLANCA

The paper outlines the details of the design and difficulties that had to be overcome in the course of the renovation and adaptation of a rich German factory owner's residence from 1912, which in 1988 was entered into the register of historic buildings of the Warmia and Mazury region.

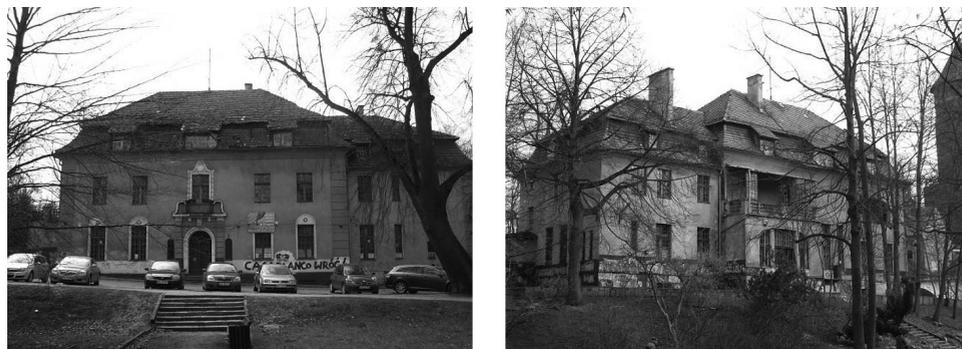
Fig. 1, 2. The front and back elevations of Villa Casablanca, before the renovation in 2006

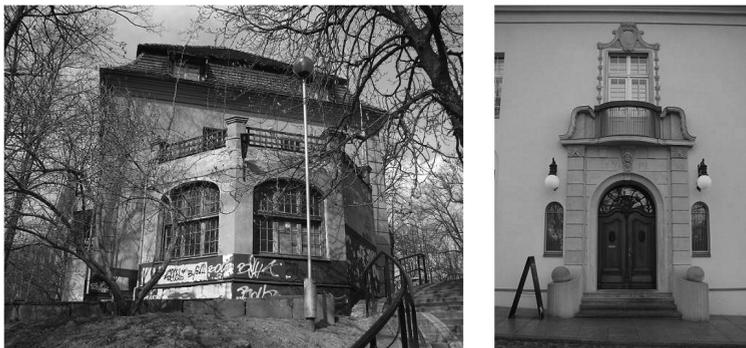
Fig. 10, 11. The eastern Casablanca elevation before renovation (2006) and the main entrance after the renovation (2014)

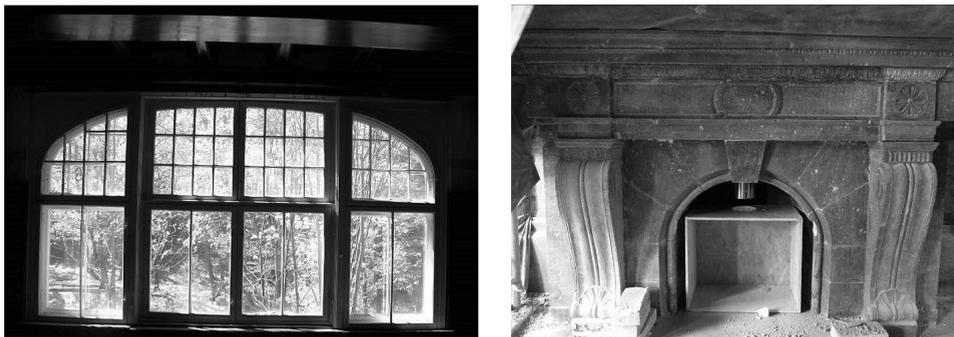
The windows of the attic and the maintenance areas of the building were almost completely destroyed, while the almost one hundred-year-old windows of both the ground (Fig. 17) and the first floor were accepted for restoration. Above the windows, there are the roller blind boxes, unfortunately, no remaining roller blinds were found.

The interior is quite well preserved with historic ceilings, stairs, panelling and fireplaces (Fig. 18). However, the stuccowork decoration of the representative chambers, the art nouveau window bars in the roof windows and the historic carved doors all needed thorough renovation.

Fig. 17, 18. The splendid window in the dining room (2006) and the historic fireplace during the restoration process, 2011

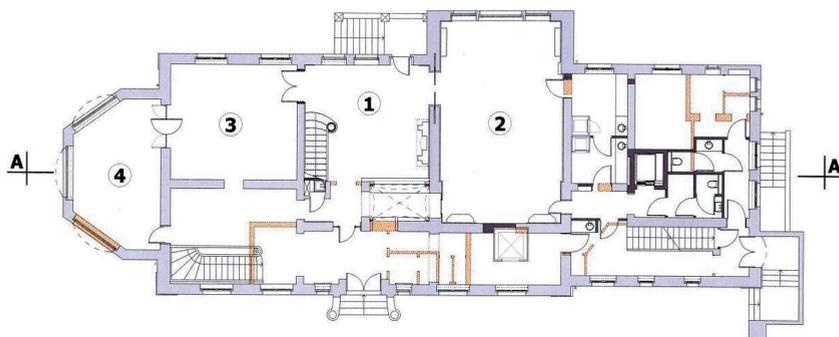
Fig. 20. A ground floor plan: 1 – fireplace ballroom; 2, 4 – conference halls; 3 – secretary office. Existing walls and ceilings – grey; walls devoted for demolition – orange; new walls and ceilings – black

The ground floor consists of: 48.40 m<sup>2</sup> fireplace ballroom; conference halls of 39.30 m<sup>2</sup> and 66.30 m<sup>2</sup>; an office of 30.50 m<sup>2</sup> (rooms numbered as 1, 2, 3, 4, in the Fig. 20); sanitary and catering facilities for serving the conference halls.

The original, presentable, wooden staircase from the conference hall in the ground floor was restored (Fig. 25), as well as the ceramic stairs on steel beams in the maintenance area of the building. On the ground floor, to the left of the main entrance, a new staircase leading to the restaurant was made (Fig. 20).

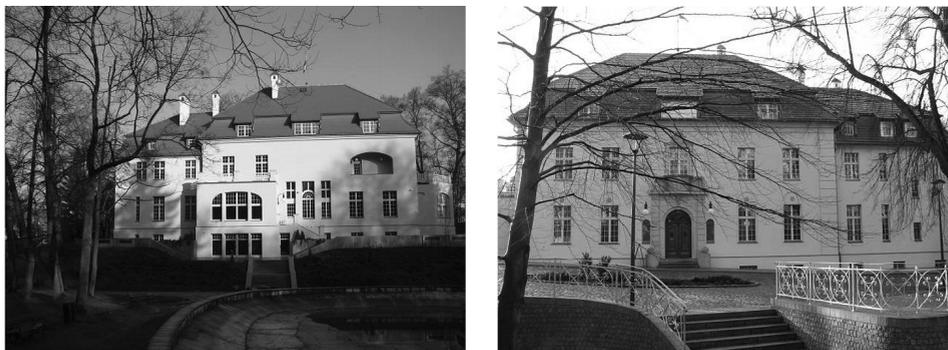
Fig. 27, 28. The front and southern Casablanca elevations after the renovation, 2014

The roof structure required only minor repairs, but the roofing was completely replaced (the colour of the new plain tiles perfectly matched the original).

The old, damaged plaster of the diverse structure covering the external walls, which was successively repaired by applying more new layers in the past, was removed, and after scrupulous stratigraphic studies, the original colour of the elevation was restored.

The surroundings of the villa were cleaned up. The historic Jewish mazewas from the park side slope were moved to the funerary house at Zyndram of Myszkowice Street, and the slope was strengthened and planted with new greenery (Fig. 27). In front of the building, the street was cobblestoned, and a car park and a new descent to the square were built (Fig. 28).
