JUSTYNA JASKOWSKA-LEMAŃSKA, DANIEL WAŁACH\*

## METHODS OF REINFORCING HISTORICAL WOODEN CEILINGS ON THE EXAMPLE OF THE PALACE COMPLEX IN GORZANÓW

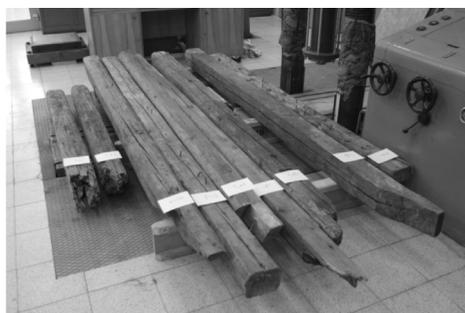
Fig. 8. Elements collected for tests

In order to assess the technical state of structural wooden elements and the load-bearing capacity of existing ceilings, material samples were collected for non-destructive and destructive laboratory tests.

Destructive tests were conducted according to standards PN-77/D-04227, PN-77/D-04229, PN-79/D-04102, PN-79/D-04103; and the following parameters were determined on their basis: dampness, density, compressive strength along fibers, compressive strength transverse to fibers, flexural strength. In the case of the modulus of elasticity, tests on small samples without flaws were abandoned in favor of tests on full-dimensional elements. Obtained values of individual parameters are presented in table 1. Based on obtained results, the class of wood was determined according to standard PN-B-03150:2000 as C18. The decisive parameter that classified the tested material in a given class of wood proved to be the modulus of elasticity.

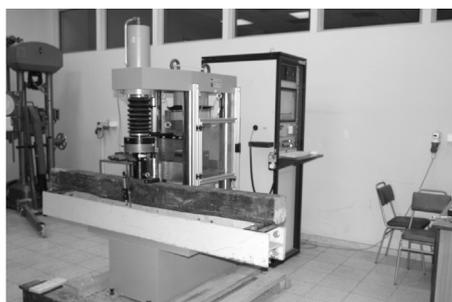
Fig. 9. Testing of beams in technical scale – view of test apparatus

The bending test was conducted as a non-destructive laboratory test on ceiling elements at their actual size. The maximum concentrated force for which studied elements fulfilled the limit use state condition ( $\max u = L/167$ ) was determined. The method of conducting tests has been presented on Fig. 9, and obtained results are listed in Table 2. The results of the test show a dependency between the state of the wood and its load-bearing capacity. However, results should not be compared directly, because the tested elements had differing cross-sections.

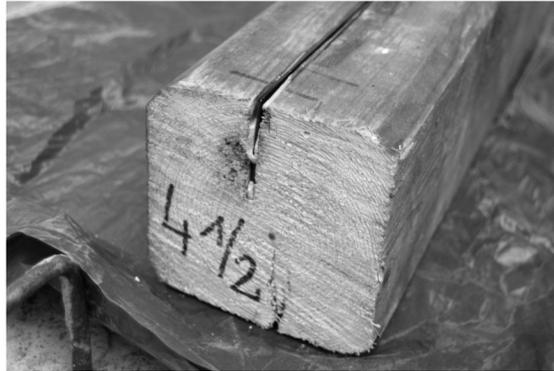
Fig. 13. Reinforcement of ceiling beams in the palace in Gorzanów

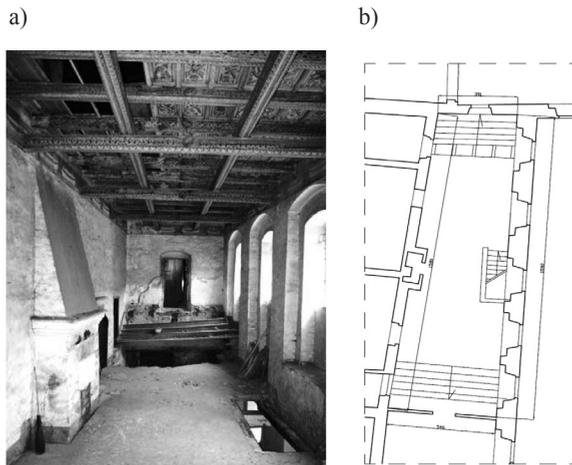
Fig. 14. „Fireplace” room: a) current state, b) projection

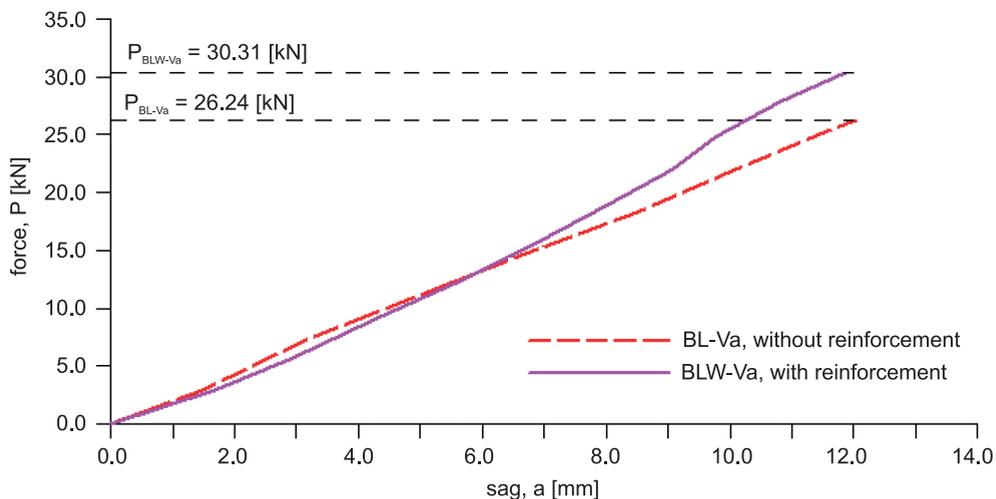
Analysis of reinforcement of the ceiling above the “Fireplace” room through gluing of CFRP tape into individual ceiling beams indicates that this type of structure would be capable of carrying both constant loads as well as operational loads acting on the ceiling. It is to be emphasized that the improvement of the load-bearing capacity of reinforced beams is directly

dependent on the method of gluing CFRP tapes. It can therefore be accepted that the level of reinforcement can be appropriately shaped in this way with the preservation of the same elements in the ceiling.

Fig. 19. Improvement of the load-bearing capacity of BL-VA beam in the scope of SGU reinforced with CFRP tape
