FIRE TESTS WITH DOORS.

A 2-in. FRAMED HONDURAS MAHOGANY
DOOR, WITH 2-in. SOLID PANELS.

A 2-in. FRAMED POPLAR DOOR, WITH
2-in. SOLID PANELS.

FIRE TESTS, V AND W, NOV. 1ST, 1899.

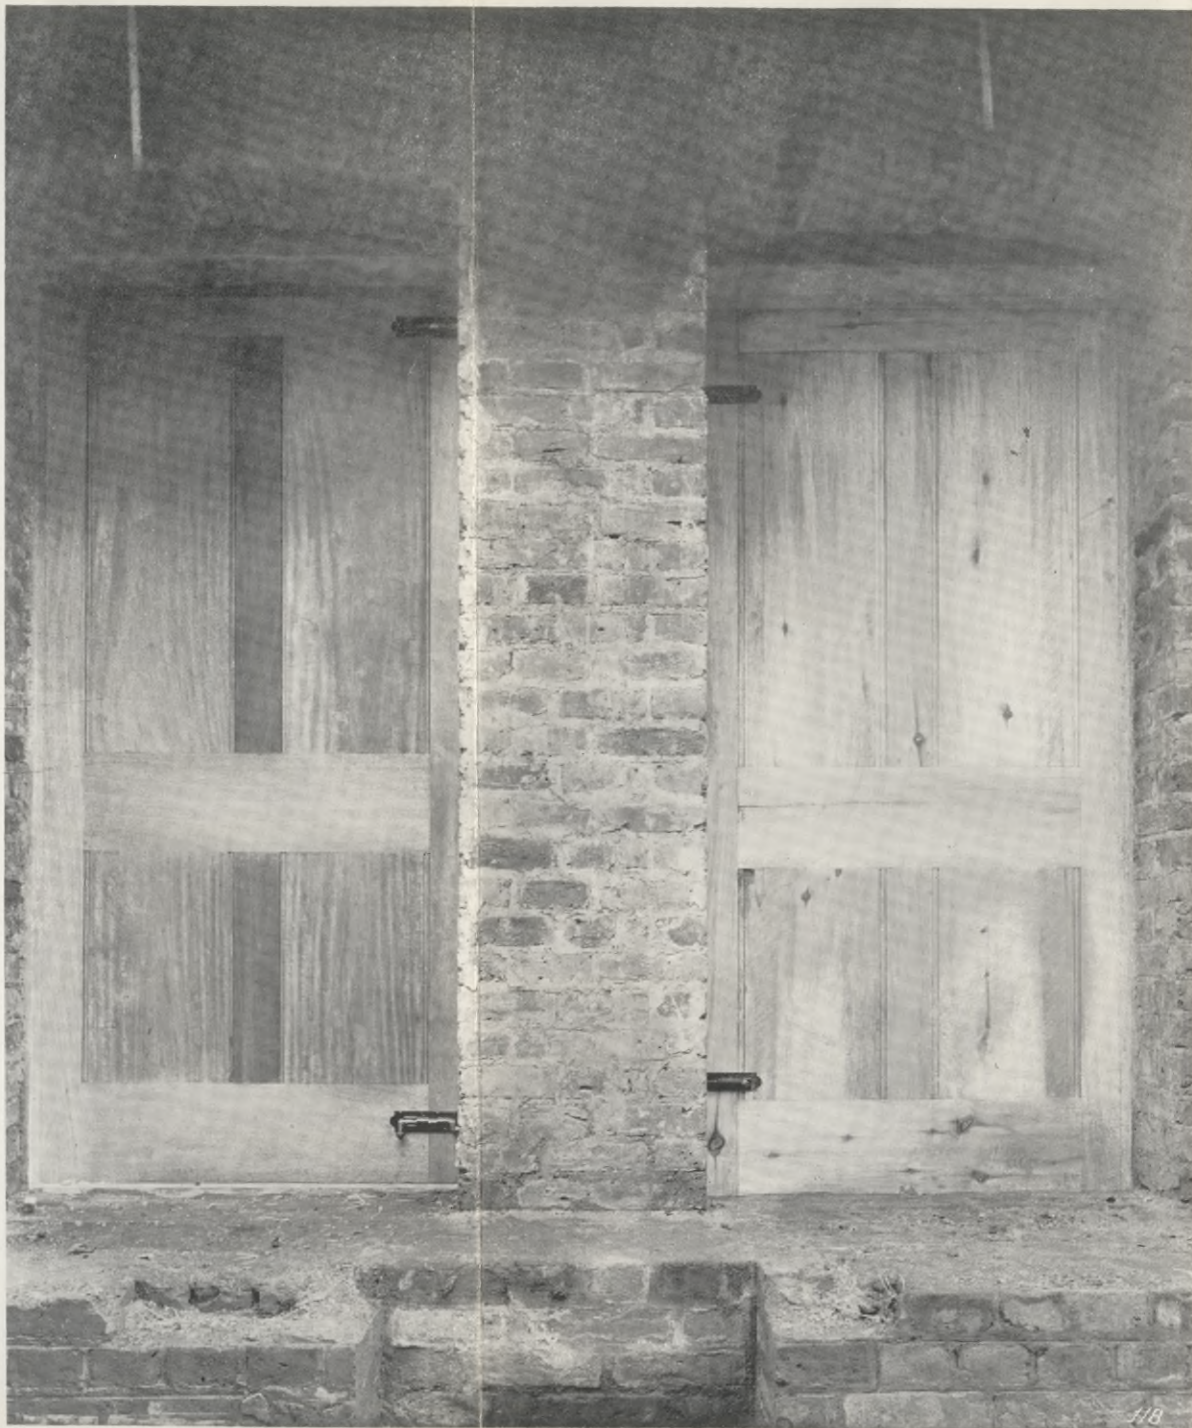
Fig. 6. VIEW SHOWING DOORS FROM OUTSIDE BEFORE COMMENCEMENT OF TEST.

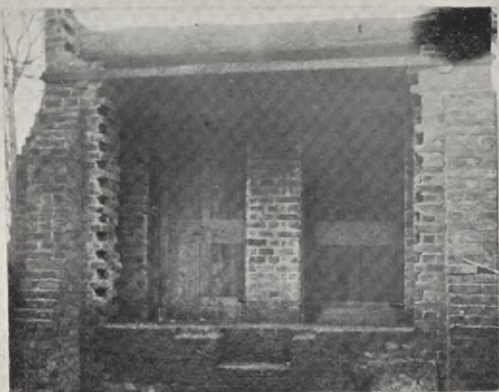
At 2.53 p.m. smoke continued coming through the joint between frame and top rail, also some flame. (See Fig. 1.)

FIG 1 TEMP 1075° TIME 2.45pm

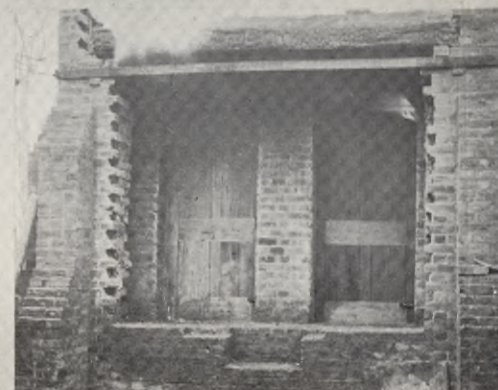
At 3.7 p.m. bottom rail of door curved inwards in the centre $\frac{1}{2}$ in. at the widest point, and flame was visible down joint between frame and west style. (See Fig. 4.)

FIG 4 TEMP 1630° TIME 3.0pm

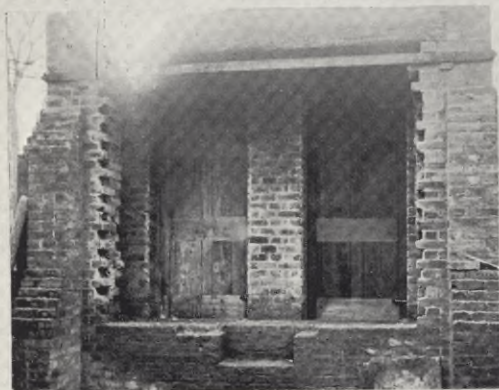
At 3.14 p.m. top west panel fell in. (See Fig. 5.)

FIG 5 TEMP 1590° TIME 3.5pm

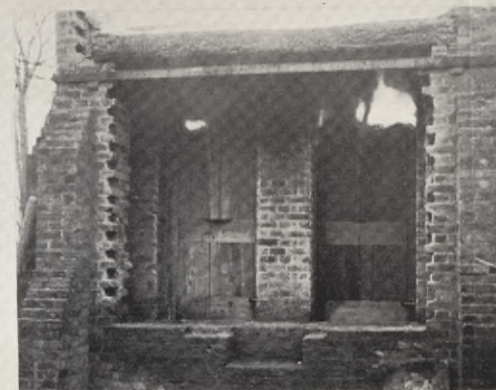
At 3.27 p.m. joint between sill and bottom rail burnt all along, leaving an opening of about 1 in., and slight flame coming through the joints between frame and east and west styles at level of middle rail. (See Fig. 8.)

At 3.26 p.m. the last portion of door fell inwards. (See Fig. 8.)

FIG 8 TEMP 1900° TIME 3.20pm

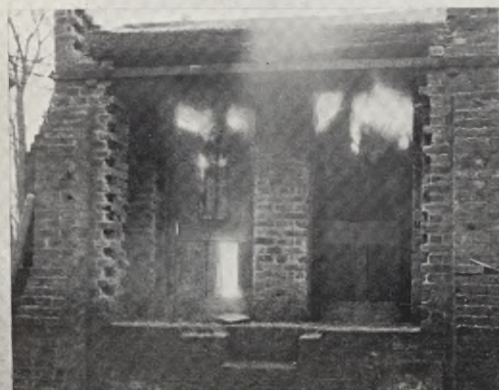
At 3.31 p.m. half of top rail, east side, fell inwards. (See Fig. 9.)

At 3.35 p.m. top of door twisted inwards, leaving a space of 1 in. between door and frame (See Fig. 9.)

Note.—At 3.33 p.m. temporary sheathed door put up to cover the opening where door was. (See Fig. 9.)

FIG 9 TEMP 1450° TIME 3.25pm

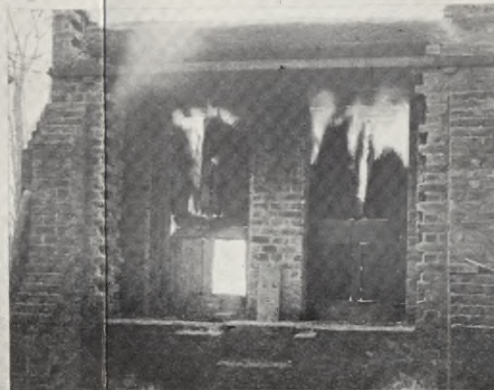
At 3.39 p.m. door fell inwards. (See Fig. 10.)

FIG 10 TEMP 1400° TIME 3.30pm
