# FIRE TESTS WITH DOORS.

A  $2\frac{5}{8}$  IN. DOOR IN OAK, CONSTRUCTED IN  
THREE THICKNESSES.

A  $2\frac{5}{8}$  IN. DOOR OF TEAK, CONSTRUCTED IN  
THREE THICKNESSES.

FIRE TESTS Fa & Ga.—APRIL, 11TH, 1900.

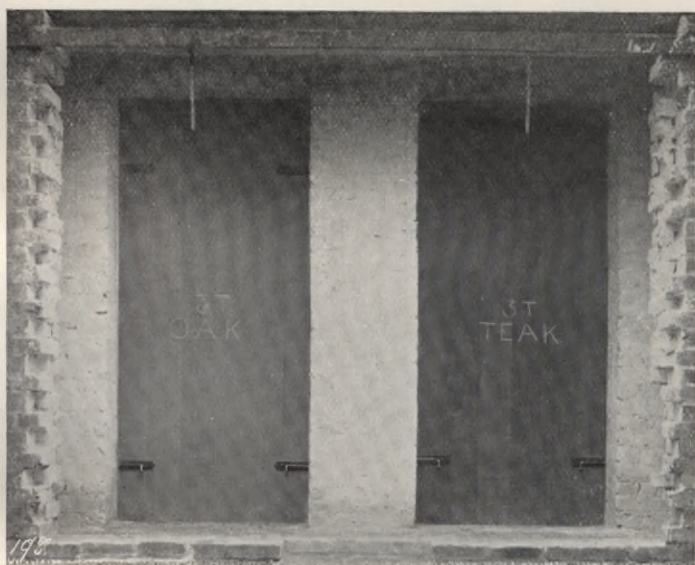
Fig. G. VIEW OF DOORS BEFORE COMMENCEMENT OF TEST.

The door on the east side was of oak, and that on the west side of teak.

The doors were of the same style and constructed in the same manner, being 6 ft. 10 in. high, by 3 ft. 2 1/2 in. wide, and formed of three thicknesses of 3/8-in. boards, between 6 in. and 7 in. wide.

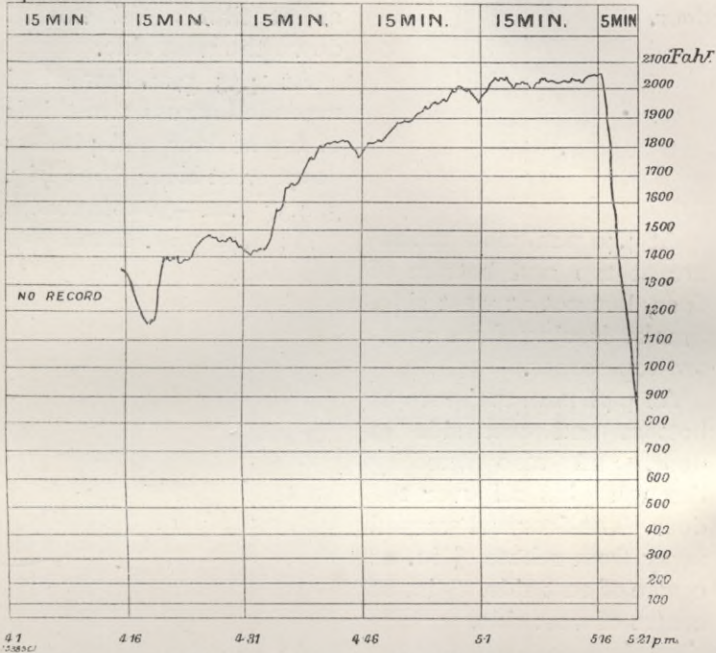
## AUTOMATIC RECORD AT POINT NO. 5.

April 11<sup>th</sup> 1900 (Doors)

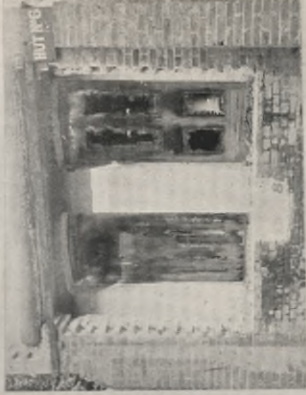
FIG. 6. TIME 4.55. TEMP 1460°

At 4.50 p.m. flames continued to issue from western corner. (See Figs. 6 and 7, 4.47 p.m. and 4.52 p.m.)
