Historical church diagnostic with regards to impact of traffic included vibrations

Krzysztof Koziol^{1,*}

¹Cracow University of Technology, Institute of Structural Mechanics, 31-155 Kraków, Warszawska 24 St., Poland

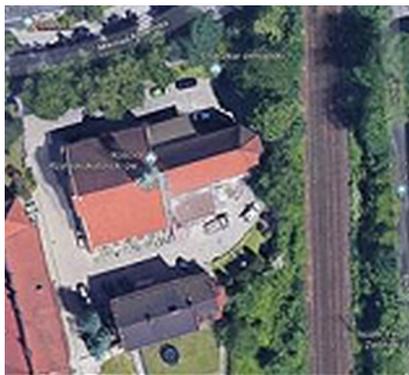
Fig. 1. Location of the analyzed object with vibration sources.

Church of St. Nicholas is located in the central part of Krakow. Near the church, from the eastern side, there are located train tracks on the embankment and on the north side - a street on which cars move (see Figure 1).

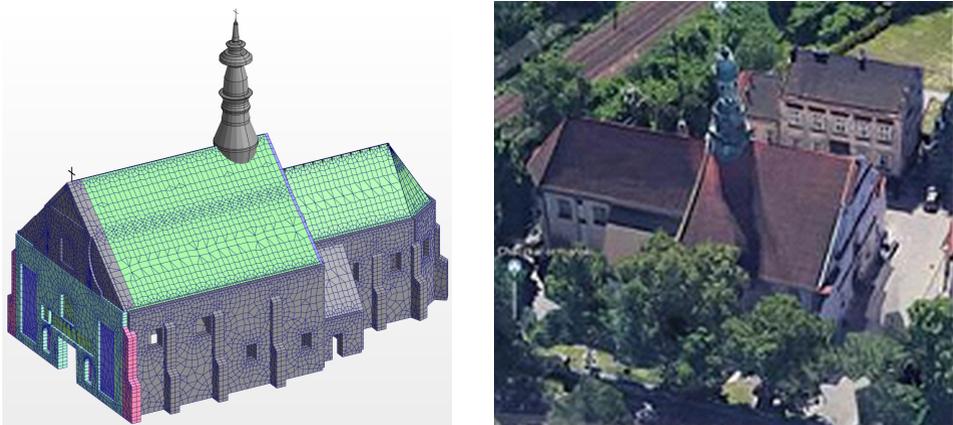
Fig. 3. Division of the computational model into finite elements and photo google maps.

Recorded vibrations waveform were used to carry out analysis allowing assessment of the influence of vibrations of communication origin onto the church structure. For this purpose a 3D FEM model of the structure was prepared. Fig. 3 shows the applied division of the structure into finite elements.

Dimensions and distribution of finite elements were adopted in accordance with the available documentation, including its verification during the damage inventory. Applied calculation model also takes into account the larger damage occurring in the construction,
