Faculty of Mining and Geoengineering, AGH University of Science and Technology

Jastrzębska Spółka Węglowa S.A.

THREATS OF FLOODING OF SELECTED MINING AREAS – REPAIR MEASURES

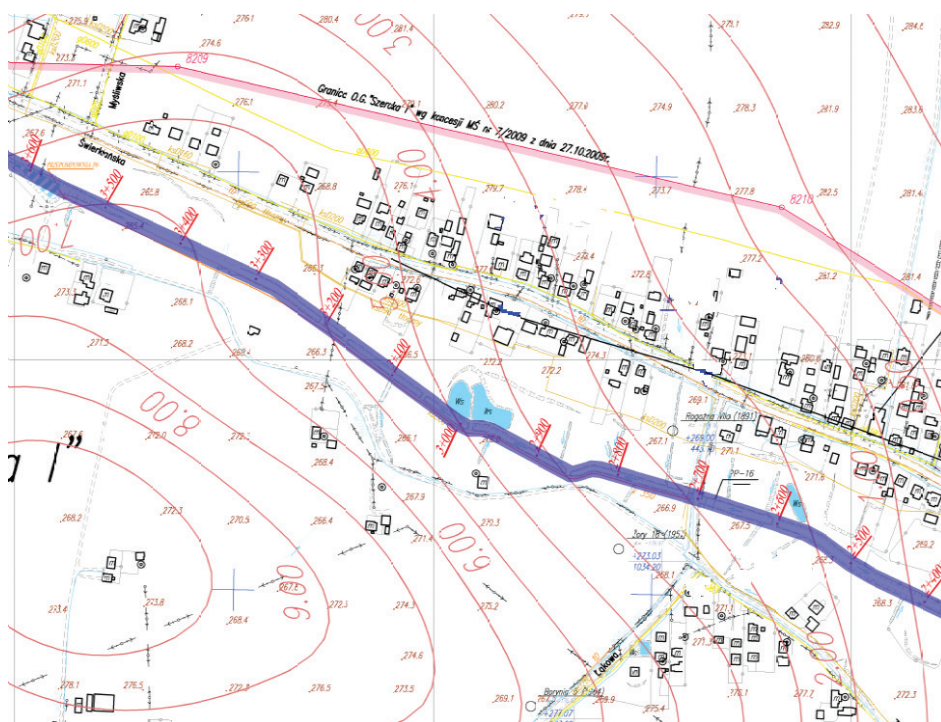
The longitudinal section of the analysed section of the Boryński stream illustrates that the riverbed of the stream is slanted in the opposite direction to the outflow of water from the catchment area (Fig. 6). This results in no outflow from the catchment area and the emergence of overflow land. The existing pumping station is unable to effectively pump out the water flowing within the Boryński stream riverbed. The outlet of the pressure piping of this pumping station is permanently flooded due to the lack of runoff.
