TECHNICAL TRANSACTIONS 11/2019

Anna Martyka (D) orcid.org/0000-0001-7582-78280

The second life of a shooting range — the conservation and adaptation of the historic shooting range at Wola Justowska in Krakow for its new function

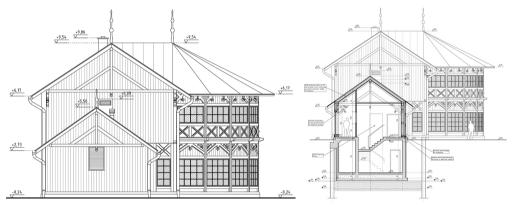
Fig. 13. Eastern elevation of the shooting pavilion (Source: PKZ ARKONA Sp. z o. o.)

brick paint and the wall surface sections were left the colour of natural wood. The preserved elements of the original ironwork were subjected to metal conservation. The roof surface was insulated from the outside in order to keep the elements of the roof truss visible from the inside. The wooden decorative detail was reconstructed in the original form and vertically planked. Decorative constructions of the avant-corps and the apse were also made [2] (Figs. 11–14).
