Sławomir Kowalski (skowalski@pwsz-ns.edu.pl)
The State Higher Vocational School in Nowy Sącz, Poland

THE INFLUENCE OF A CrN+a-C:H:W COATING ON THE DEVELOPMENT
OF FRETTING WEAR IN A MODEL OF A WHEEL–AXLE PRESS-FIT JOINT
ON A WHEEL SET OF A RAILWAY VEHICLE

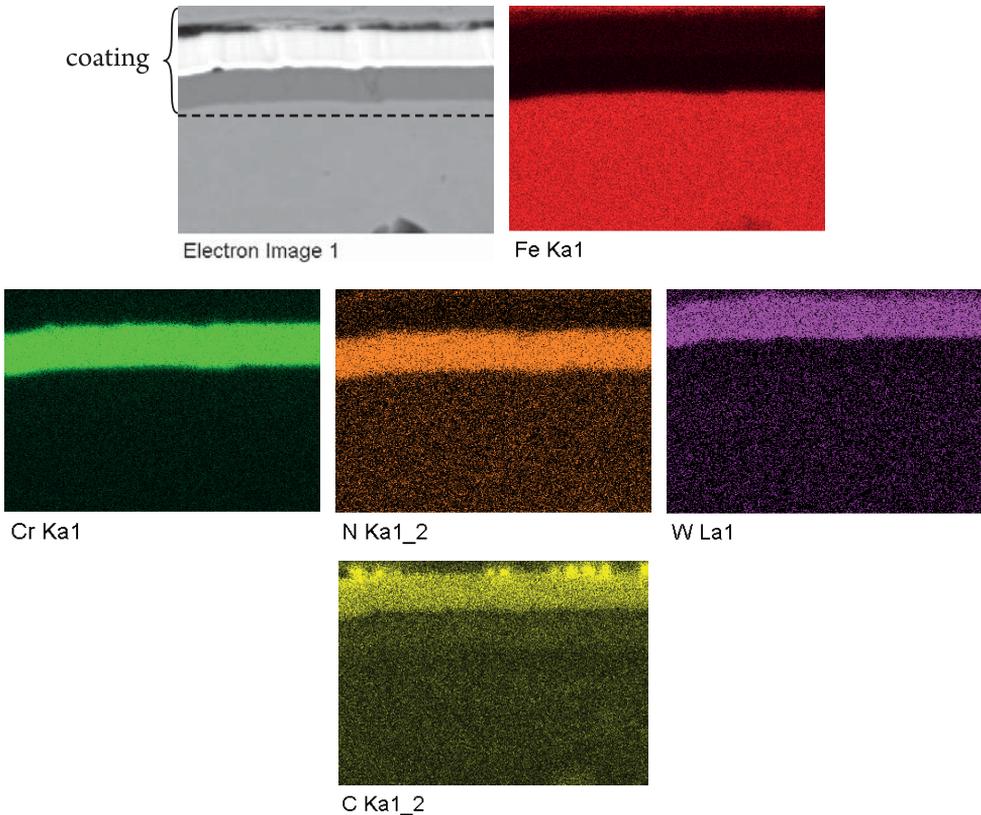
Fig. 1. Element distribution maps showing the chemical composition of the coating

The coating was applied to the shafts by means of the reactive spraying method in a PVD process. The coating structure and chemical composition in the form of a chemical element distribution map is presented in Fig. 1. The coating consists of three layers and is colloquially called WC/C. The first layer is chromium nitride (CrN), the task of which is to improve coating adhesion to the surface of the steel base. The next layer is tungsten carbide (WC), which protects the surface of the base against abrasion and is responsible for the transfer of high pressures. The third layer, called the external layer, directly mates with the sleeve. According to literature, the atomic composition of this layer is as follows: 12% W, 70% C, 15% H, 3% Ni [15–16]. Nickel is an outcome of the coating generation process.

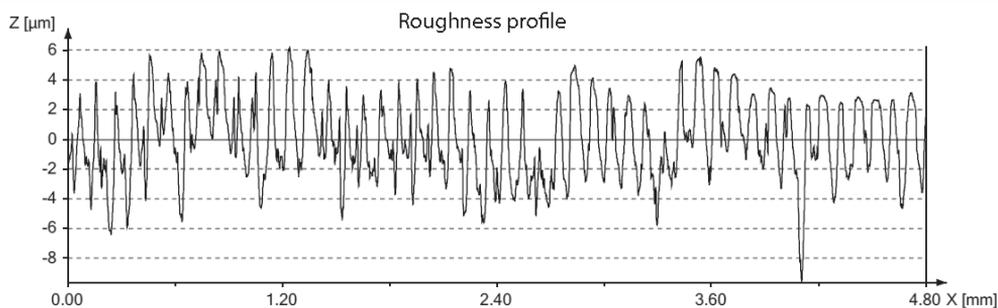
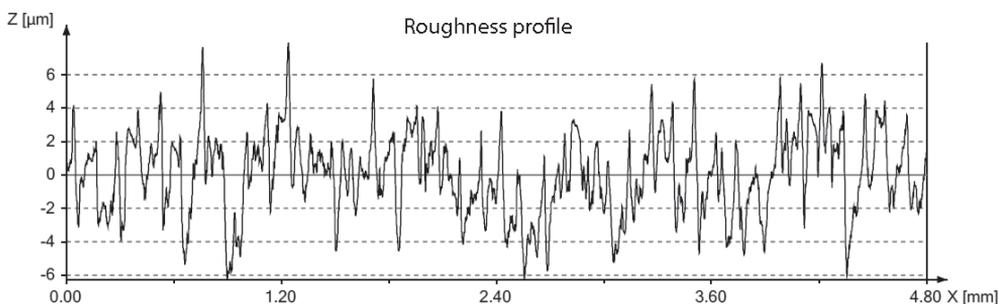
In the case of the tests of fretting wear in a press-fit joint, the appropriate hardness of the top layer and its roughness parameters prior to joint assembly play an important role. The roughness profile and selected parameters of the uncoated (a) and coated (b) top layer of the shaft are shown in Fig. 2.

a) uncoated shaft

Ra	2.06 μm	Rz	11.15 μm	Rmr(c=2.78 μm)	18.062 %
----	--------------------	----	---------------------	----------------------------	----------

b) coated shaft

Ra	1.68 μm	Rz	11.57 μm	Rmr(c=2.78 μm)	1.300 %
----	--------------------	----	---------------------	----------------------------	---------

Fig. 2. Roughness profile of the shaft surface

Test results confirmed the tests conducted by other authors specifically that input parameters of the top layer of the elements being connected have significant influence on the development of fretting wear. Appropriate roughness and hardness parameters reduce wear intensity. Tested coatings have, indeed, slightly lower roughness parameters in comparison with the uncoated shaft, but increasing top layer hardness by 25% proved sufficient for the reduction of adhesion and also of fretting wear.

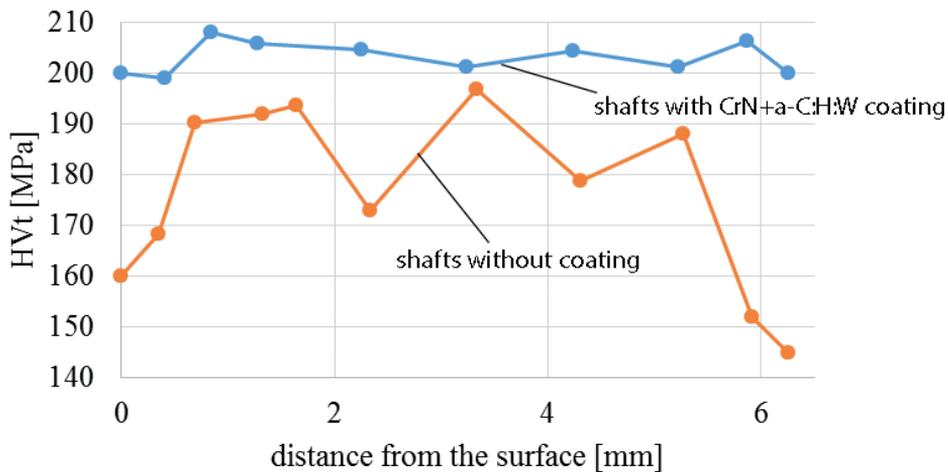
The diagram showing shaft microhardness in the function of the distance from the surface is presented in Fig. 3.

Fig. 3. Microhardness distribution

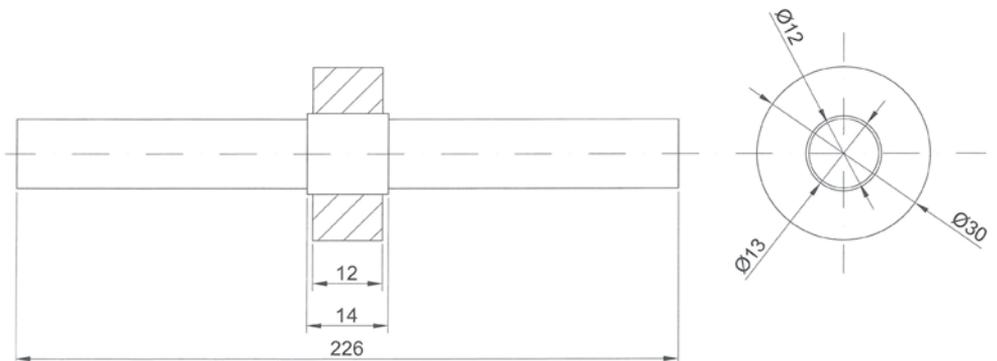
Wear tests were conducted on a model of a wheel/axle push fit joint of a railway vehicle wheel set. The model consists of a sleeve forced onto a shaft with 0.02 mm negative allowance.

The model was designed in such a manner that the dimensional similarity to the real wheel set is retained. Retained – this primarily concerned the shaft and sleeve connection zone. The shaft length and diameter were dependent upon the fatigue testing machine structure. The diagram of the sample with dimensions is presented in Fig. 4.

Fig. 4. Diagram of the test model with dimensions

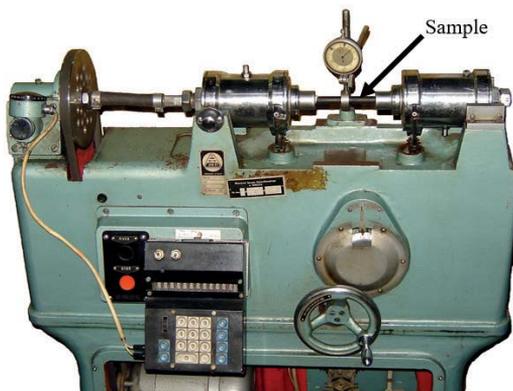
In addition to an appropriate test model, the selection of a wear test station – which will, to the maximum extent, reflect the wheel set operational conditions described in the introduction – is an important issue. Primarily, the test station should enable the oscillatory tangential displacement of the mating surfaces. One such machines which meets the criteria is a MUJ fatigue testing machine, the structure of which is presented in Fig. 5.

Fig. 5. The structure of a fatigue testing machine

The machine structure enables the generation of a periodically variable load with pure bending of a rotating model. Railway vehicle wheel sets rolling on a straight track (a situation when a railway vehicle does not move on a bend and hunting oscillation does not take place) are subjected to similar conditions. A situation in which a vehicle is on a bend was not covered in the tests.

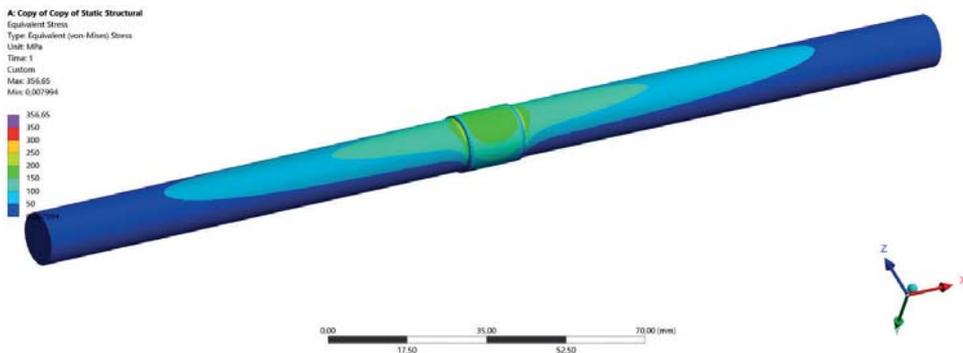
The FEM analysis performed in the ANSYS software permitted the selection of the maximum value of a force which causes shaft deflection without leading to plastic deformation. The assumed 550 N force causes the maximum stresses to be reduced to 356 MPa (Fig. 6) and leads to maximum sample deflection, which is 0.52 mm. The most important parameters of wear tests are summarised in Table 2.

Fig. 6. Distribution of reduced stresses

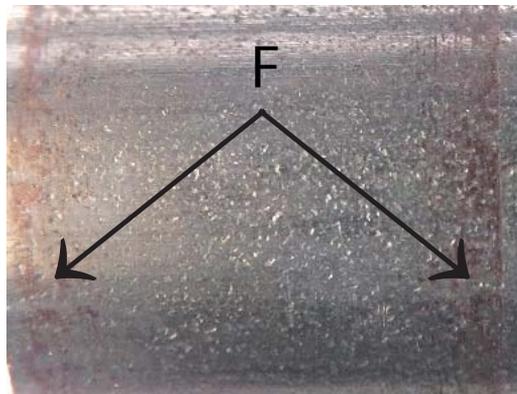
Macrographic observations (Fig. 7) of the uncoated shaft surface confirm the test results obtained by the authors of [6, 17, 18], which show that fretting occurs at joint edges in the case of press-fit joints.

Fig. 7. The macrographic image of the shaft surface, F – fretting wear

In the case under analysis, fretting wear occurs around the entire circumference of the shaft axle seat. The width of the ring affected by wear reaches 2-3 mm and is the same on each side of the axle seat. Wear occurs at a distance of 2-5 mm from the axle seat edges. The tests of the topography of the top layer at the place of fretting wear indicates a considerable increase of the roughness parameters. The probable cause of the roughness increase is the wear products.

The tests demonstrated that in the case of a joint in which the shaft top layer was not covered with the relevant coating, fretting wear occurs around the entire circumference in the form of a ring, the width and distance of which from the joint edge are different at each side. Fretting wear, of considerably lower intensity, however, was also observed on the surface of the coated shafts. Fretting wear occurred over the entire circumference, covered small areas of various shapes, and was spaced at random.

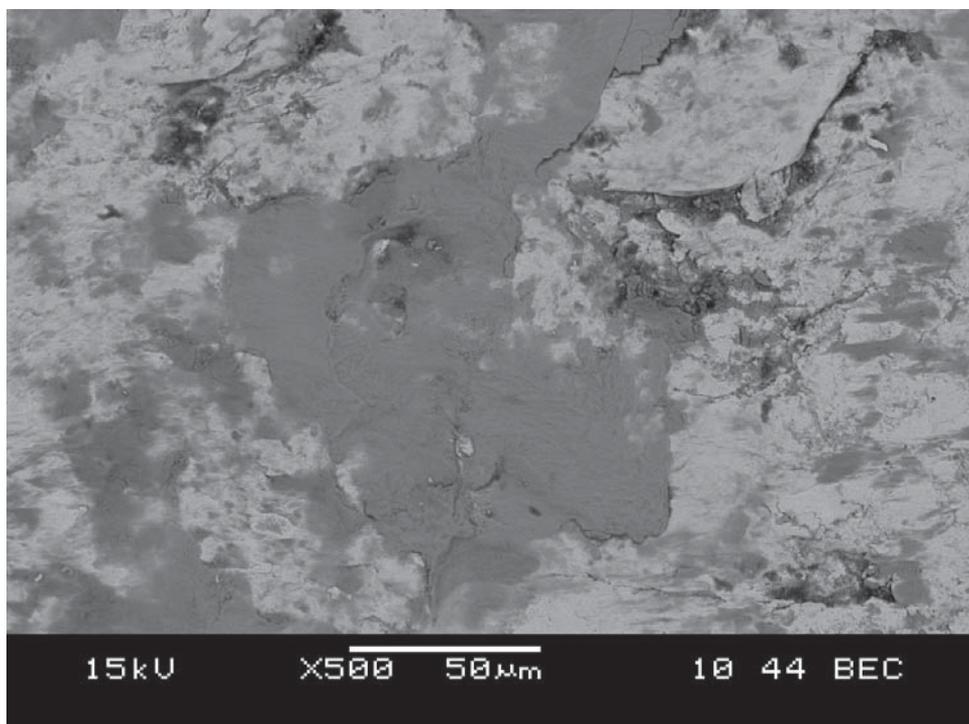
Microscopic observations with the use of an SEM confirm that the responsibility for the increase of roughness parameters rests to a large extent with material build-up at the shaft surface in the fretting wear zone visible in Fig. 8. Further observations show occasional occurrences of microcracks and micro-abrasion.

Fig. 8. The SEM image of the shaft surface in the fretting wear zone

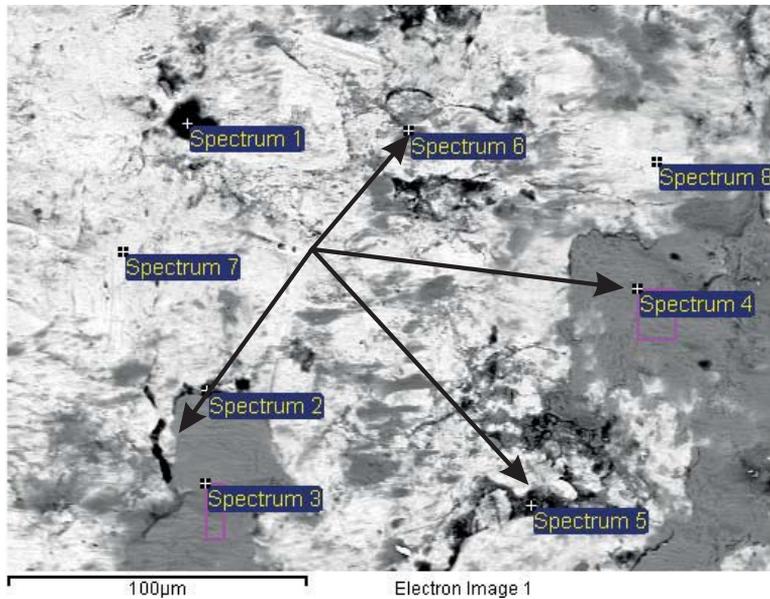
Spectrum	Fe	O	C	Na	Si	S	Cl	K	Ca	Mn	Total
Spectrum 1	21.8	13.2	59.2	1.3	0.8	0.9	1.2	0.6	1.0	–	100.0
Spectrum 2	51.4	16.7	26.4	1.4	1.3	0.5	0.8	0.5	0.5	0.4	100.0
Spectrum 3	64.4	34.8	–	–	0.3	–	–	–	–	0.5	100.0
Spectrum 4	60.7	38.5	–	–	0.4	–	–	–	–	0.4	100.0
Spectrum 5	56.2	27.7	14.7	–	0.3	–	–	0.2	0.4	0.5	100.0
Spectrum 6	61.9	31.6	3.7	–	1.7	–	–	0.5	–	0.5	100.0
Spectrum 7	99.3	–	–	–	–	–	–	–	–	0.7	100.0
Spectrum 8	99.4	–	–	–	–	–	–	–	–	0.6	100.0

Fig. 9. EDS analysis of the elements at the shaft surface in the fretting wear zone

A peculiar feature of fretting damage is the brown colour typical of steel corrosion. This follows from the fact that wear products damage that has come into being as a result of adhesive bonds and, subsequently, plastic deformation, are susceptible to oxidation. This fact is confirmed by the EDS analysis of the chemical composition of wear products in the place of fretting wear. In Fig. 9, places marked with arrows show fretting damage in the form of material build-up. These places have an oxygen content from 27% to 40%; therefore, iron oxides come into being. The remaining measured places also contain oxygen, but its concentration is considerably lower.

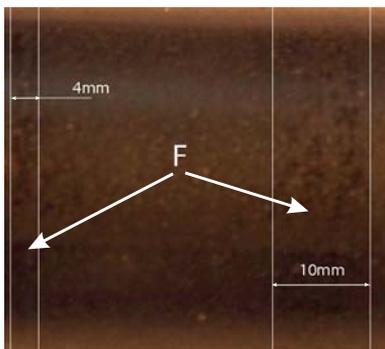
Macroscopic observations of the coated top layer of the shaft after wear tests demonstrated fretting wear traces (the 'F' in Fig. 10). As in the previous case, these are located by both joint edges. The first traces appear 2 mm from the edge. Wear affects is randomly located at the axle seat circumference. The smallest surface area affected by wear is 0.5 mm², and the largest is approximately 14 mm². The width of the 'strip' affected by wear is different on each side.

Fig. 10. The surface of a shaft with a CrN+a-C:H:W coating after wear tests

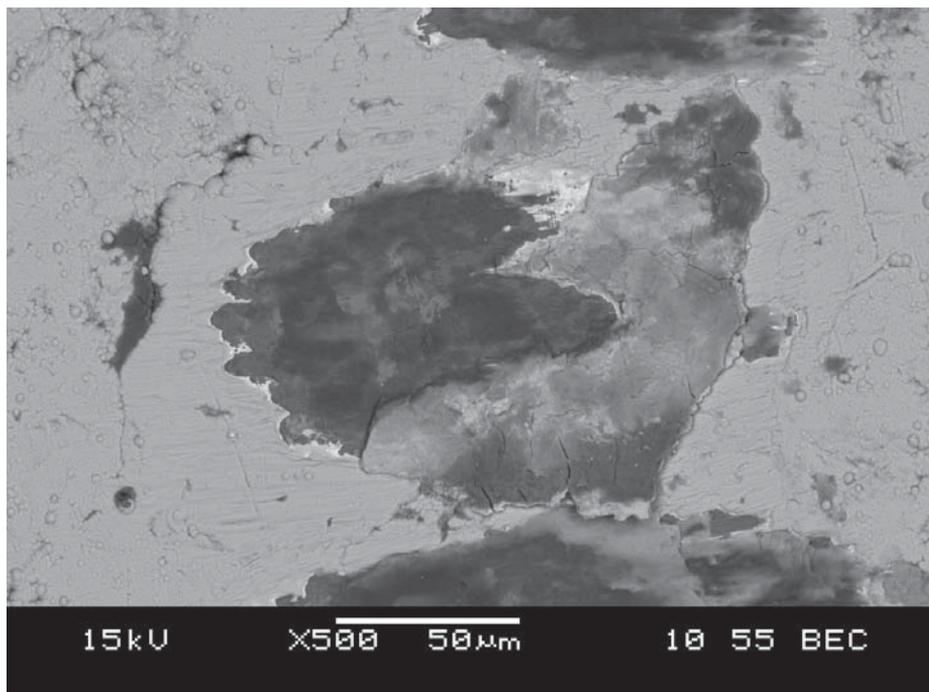
Fretting comprises, to a large extent, material build-up most probably originating from the tearing off of the sleeve top layer micro-irregularities (Fig. 11). The inferior properties of the sleeve hub top layer in relation to the coated shaft axle seat cause precisely the sleeve hub surface to be susceptible to damage during joint assembly.

Fig. 11. Fretting in the form of material build-up on the coated shaft surface

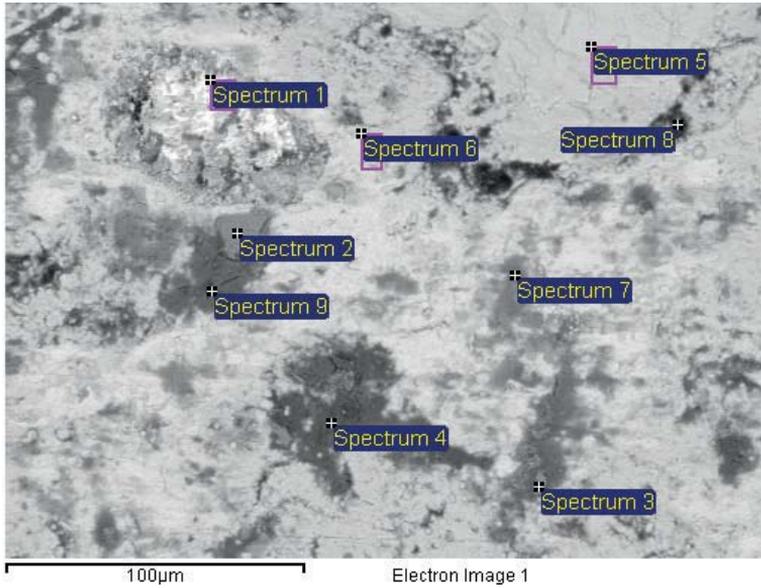
This assumption is confirmed by the analysis of the elements occurring on the shaft surface in the fretting wear zone. The results of the analysis of the chemical composition at selected points of the shaft surface within the fretting zone are presented in Fig. 12.

Spectrum	Elements related to the coating and sleeve structure					Elements related to the process of sample preparation for laboratory tests				Total
	Fe	O	C	W	Cr	Si	Ca	Mn	Ni	
Spectrum 1	7.1	5.4	19.4	53.7	10.6		–		3.8	100.0
Spectrum 2	94.6	–	3.4	–	0.9	0.4	–	0.7	–	100.0
Spectrum 3	93.8	–	4.1	–	1.0	0.4	–	0.7	–	100.0
Spectrum 4	41.2	26.5	–	29.5	1.0	–	–	–	1.7	100.0
Spectrum 5	0.6	1.0	26.1	66.8	0.9	–	–	–	4.6	100.0
Spectrum 6	3.1	20.1	–	71.0	1.0	–	–	–	4.8	100.0
Spectrum 7	40.3	29.1	6.2	21.9	1.3	–	–	–	1.2	100.0
Spectrum 8	15.0	15.1	48.6	17.7	2.6	–	0.4	–	0.5	100.0
Spectrum 9	42.4	26.1	–	28.5	1.0	–	0.5	–	1.6	100.0

Fig. 12. EDS analysis of the elements on the shaft surface in the fretting wear zone

During the analysis of the chemical composition for a selected area affected by wear, macroscopic observations have demonstrated that wear is random in nature and is not continuous. This is proved by the chemical composition at the survey points 'Spectrum 1' and 'Spectrum 5'. It is mainly the elements related to the coating structure (carbon and tungsten) that occur there. In the case of the 'Spectrum 1' survey point, a small amount of chromium is also observed. This is caused by the micro-abrasion of the working part of the coating, which led to the uncovering of the first coating layer containing chromium. The total destruction of the coating did not, however, take place. Iron occurring at that point probably originates from the sleeve hub. Nickel occurring in that part is an effect of the manufacturing process of the coating.

The survey points 'Spectrum 2' and 'Spectrum 3' are the proof of the shearing of the micro-irregularities on the top layer of the sleeve hub during joint assembly. During forcing, torn-off micro-irregularities creating the so-called 'third body' were moving along the joint and filling the natural microcavities in the coating. Hence, the chemical composition in these places is primarily iron. These wear products did not undergo plastic deformation and were not oxidised. They did not take part in the rise of fretting, either.

The remaining survey points demonstrate the occurrence of fretting wear. In the case of the 'Spectrum 6' survey point, material build-up mainly consisting of tungsten is observed. This is evidence of the tearing off of micro-irregularities of coating as a result of adhesion, and of the creation of build-up which underwent plastic deformation during the latter part of assembly or operation. This deformed build-up was oxidised, hence the analysis of the chemical composition also showing the occurrence of oxygen. The 'Spectrum 8' survey point also signifies damage to the coating. Material build-up at this point is composed of carbon and tungsten (i.e. elements related to the coating structure) and of a small amount of iron. This build-up also underwent plastic deformation and, at a further stage, oxidation.

Wear products see above note analysed at the 'Spectrum 4', 'Spectrum 7' and 'Spectrum 9' survey points are the material build-up in which chemical composition is a mixture of elements originating from the top layer of the sleeve hub and of the coating. However, the occurrence of iron is noted in the vast majority of cases – this means that mainly the sleeve top layer was damaged. During operation, this build-up gradually underwent plastic deformation and oxidation. The analysis of the chemical composition in these survey points showed the presence of the same or similar amount of oxygen to that of tungsten. The presence of carbon is not noted.

Trace amounts of chromium observed in the 'Spectrum 2' to 'Spectrum 9' survey points originate from the local microdamage of the working part of the coating. The remaining chemical elements – such as silicon, calcium, manganese and nickel – are the result of the surface preparation for laboratory tests or the outcome of the coating production process.
