BIOVAC® WASTEWATER TREATMENT PLANTS IN THE MOUNTAIN NATIONAL PARKS

This paper presents characteristics of the Biovac® wastewater treatment plants operating in the mountain areas of the Polish national parks (NP): Tatrzański NP and Babiogórski NP as well as in the West Spitsbergen NP. On the basis of the laboratory tests performed on raw sewage and the final effluent the efficiency of the wastewater treatment plants was evaluated. It was found that high COD values and rather high COD / BOD5 ratios were observed in the raw sewage during an off-peak tourist season. The research has also shown that the Biovac® treatment plants (SBR technology) showed a high level of removal of pollutants from sewage discharged from mountain hostels.

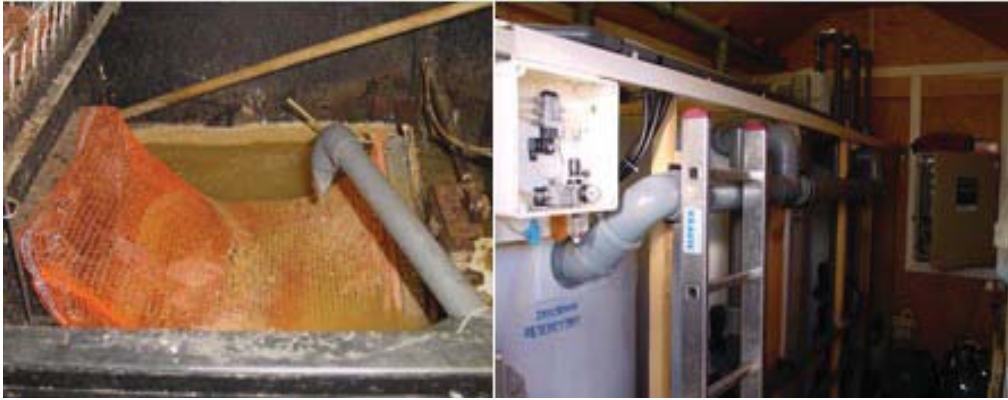
The vertical retention tank (Fig. 2) equalises the sewage flow/composition and serves as a buffer during large flow fluctuations. The tank houses submersible pumps that pump sewage to the SBRs.

Fig. 2. Biovac® wastewater treatment plant at West Spitsbergen a) bag screen , b) retention tank [10]

The mechanical (primary) sewage treatment is a stage where solids are removed from sewage. Biovac® plants usually employ basket screens and bag screens, although occasionally fine screens, sieves or screenings and grit separators (combined in a single unit) are used for larger wastewater treatment plants. The basket screen is a coarse screen made of stainless steel. This device is placed directly by the inlet in manholes or pumping stations to which wastewater is carried by pipe. It is guided by rails and has electric or hand hoist. Floating solids of a particular size are caught in the filtering compartment. The basket moves along the rails in vertical direction [10]. After being pulled out of the tank, the basket turns to a position that guarantees automatic unloading of screenings. The separated solids/screenings are transported to a storage tank or to a filter press via a gutter. The bag screen (Fig. 2) is mounted in front of the retention tank. The bag is made of plastic fibres and removes solids of a particular diameter. Similar bags can also be found in agriculture as a packing material for agricultural crops.
