JOANNA JADWIGA BIAŁKIEWICZ\*

## GREATER POLAND RESIDENTIAL ARCHITECTURE AND MONUMENT PROTECTION ISSUES

### WIELKOPOLSKA ARCHITEKTURA REZYDENCJONALNA A PROBLEMY OCHRONY ZABYTKÓW

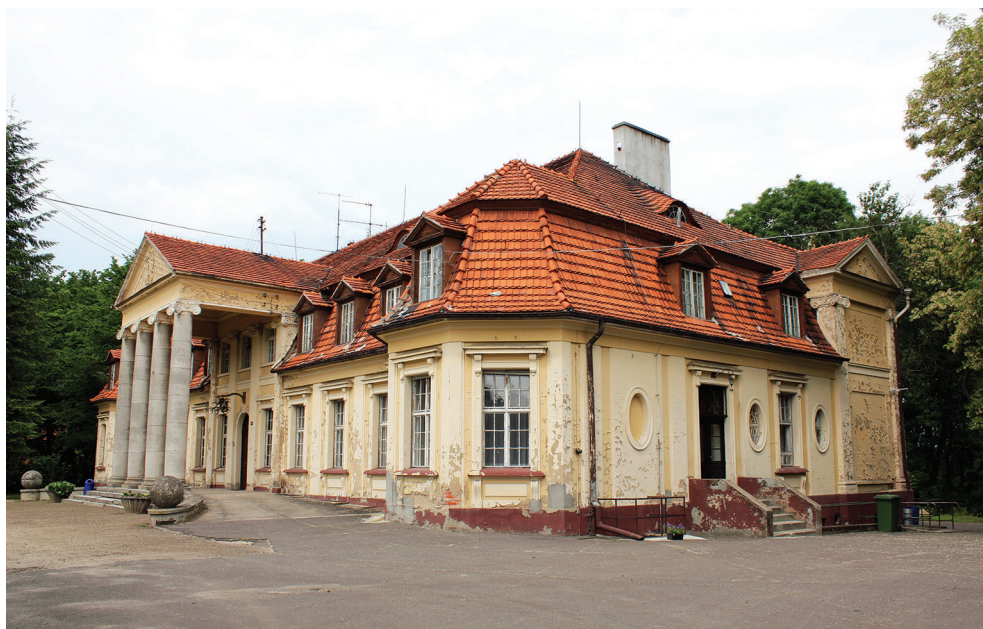
Currently the palace in Bieganowo is in a very poor condition, with far reaching devastation of the original architectural tissue. The elevations are falling into decay due to progressing moisture on the belt of the plinth as well as the foundation walls. The cracked plaster flakes off. From the side of the façade, the visitors' attention is attracted by a defacing, carelessly made driveway made of asphalt. Nevertheless, from the point of view of preservation the garden elevation is in the worst condition: the retaining wall of the terrace collapsed. This brought about the destruction of the original handrail with balusters and the statues ornamenting it, which for a long time were lying on the terrace on the ruined terrace, not protected against further devastation in any way. A closer look at the elevations reveals next problems: bad condition of the window and door woodwork, alarming condition of the gutters, the rainwater pipes and the roof tiles. The interiors of the palace have also suffered a lot, due to humidity as well as far reaching "renovations", never arranged with the preservation services, connected with covering or destroying numerous historic elements of the fittings. Interestingly enough, the devastation of the palace described above actually occurred over the last 25 years. In 1989 the state of the preservation of the residence in Bieganowo was defined as good in the Record Sheet of Monuments of Architecture and Construction<sup>11</sup>. Quite so, the photographs from that period present this building in a satisfactory condition, outside as well as inside. Therefore, the question arises, concerning the reasons for such a far reaching destruction of a legally protected monument, caused in a relatively short time.

III. 1. Pałace in Bieganowo, front and side elevation, current condition (photo by J. Białkiewicz)

II. 1. Pałac w Bieganowie, elewacja frontowa i boczna, stan obecny (fot. J. Białkiewicz)

the Wielkopolskie Province Monuments Preservation Officer set the deadline for the performance of renovation and securing works and arranging the park by the end of January 2009<sup>15</sup>. This deadline was not met<sup>16</sup>. Only in July 2009 the Agricultural Property Agency commissioned conservator's examinations, which revealed strong negligence of the architecture of the palace, as well as its surrounding area, with the progressive degradation process, calling for immediate conservator's intervention. The documentation from the examination was sent to the office in mid-September, and in December the office prepared a reply in which it conditioned the issuance of a renovation permit on completing the deficits and improving the objections towards the design filed<sup>17</sup>. The decision on the permit to conduct the first stage of the renovation works was finally issued in April 2010<sup>18</sup>. It was not, however, completed in the validity period of the document, and the Provincial Monuments Preservation Officer did not conduct any inspection which would reveal this situation. In 2012 the palace was inspected due to the planned disposal of the property. For the next time a bad condition of the elevation and a "catastrophic" condition of the terrace was revealed<sup>19</sup>, which resulted in a letter sent to the Agricultural Property Agency about the need to obtain another renovation permit<sup>20</sup>. Similarly to the previous years, however, no specific action were undertaken. When Jadwiga Szafarek was awarded the lease of Bieganowo in a tender, in April 2013 she obtained 50 thousand PLN of financial support from the EU funds, intended for the renovation of the elevation of the palace and replacement of the damaged parts of the roof<sup>21</sup>. The permit of the Wielkopolskie Provincial Monuments Preservation Officer was issued in March<sup>22</sup>. As a result of the investor's efforts, only the condition of the terrace improved after its provisional repair. The elevations and the roof are still in a very poor condition.

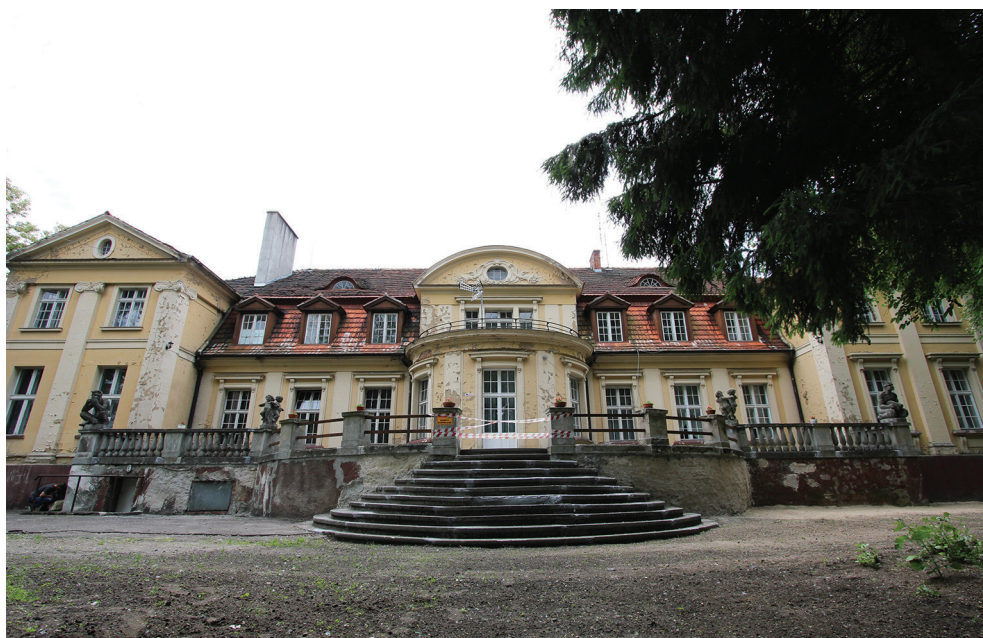
III. 2. Pałace in Bieganowo, garden elevation with a terrace, current condition (photo by J. Białkiewicz)

II. 2. Pałac w Bieganowie, elewacja ogrodowa z tarasem, stan obecny (fot. J. Białkiewicz)

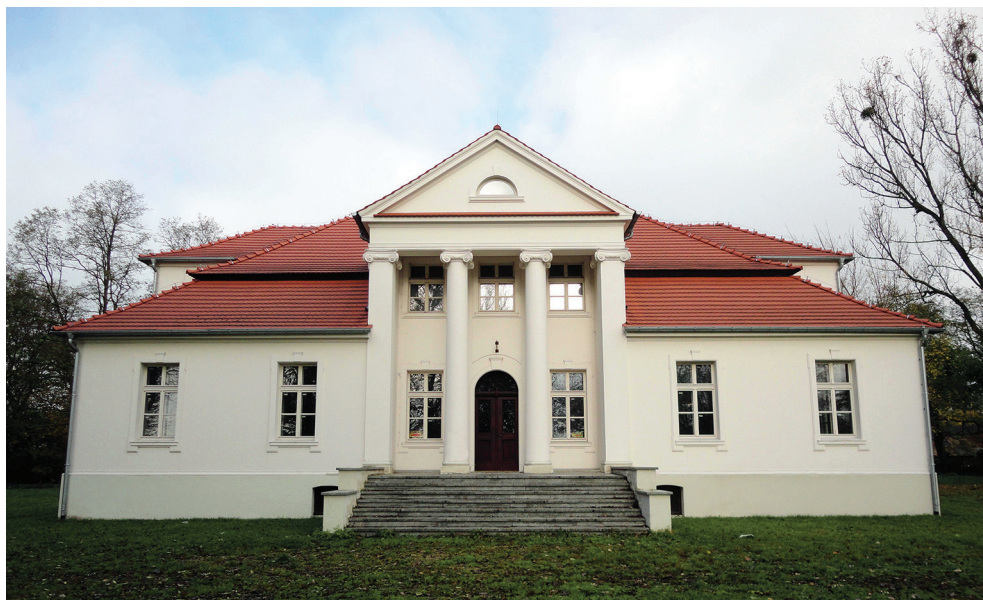
The renovation of the mansion in Wódki was realized in the years 2004–2009 and can serve as a model of revalorization of this type of buildings. The foundation, basement and ground floor walls were dried, anti-water installation was executed and plasters were renovated, maintaining in the off-white colour, characteristic for mansions and harmonizing with the light beige plinth and oak wood entrance door. The window woodwork was replaced (due to its poor technical condition), restoring the original shape of the windows. All the preserved details: window frames, cornices, heads of the columns, were subjected to maintenance works. Furthermore, the destroyed roof truss and covering in the “old” part of the mansion were replaced. New elements appeared, as well, connected with the planned hotel function of the mansion: a simple column portico with a tympanum emphasizing the main entrance to the “old” part of the mansion from the east, and a wooden porch from the west; furthermore, a “kitchen” entrance from the north (in the “old” part) was covered by a roof on wooden supports. The renovation of the interiors comprised e.g. the demolition of the secondary partition walls erected in the 1970s, cleaning, strengthening and securing the original wooden staircase in the hall, cleaning the original colours of the walls and completing the original parquet in the hall.

Ill. 3. Mansion in Wódki, front elevation, current condition (photo by J. Białkiewicz)

Il. 3. Dwór w Wódkach, elewacja frontowa, stan obecny (fot. J. Białkiewicz)

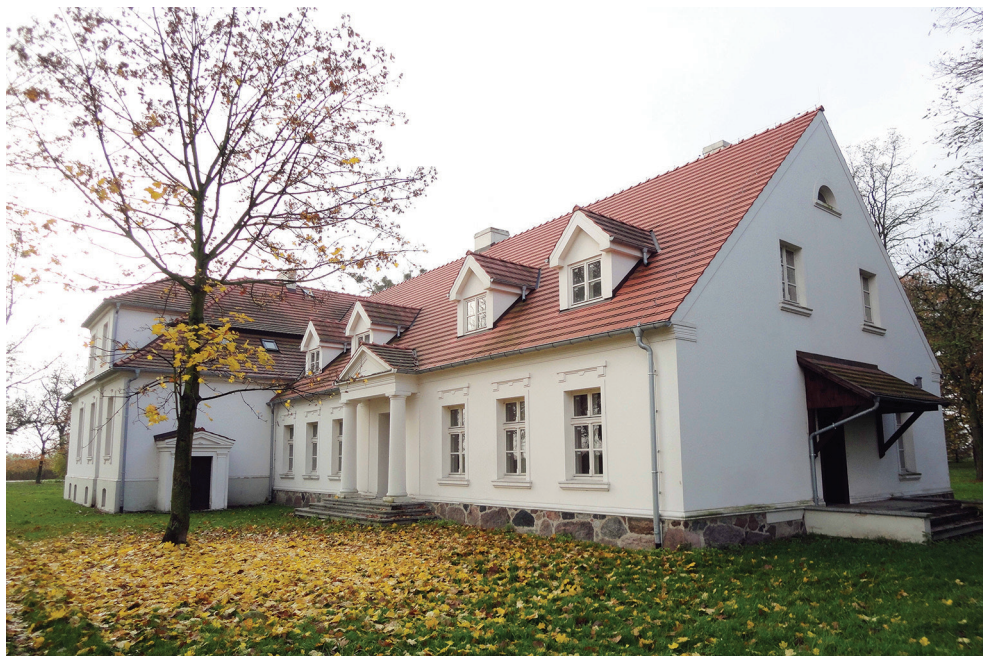
Ill. 4. Mansion in Wódki, side elevation, current condition (photo by J. Białkiewicz)

Il. 4. Dwór w Wódkach, elewacja boczna, stan obecny (fot. J. Białkiewicz)
