SELECTED SEQUENCES OF CHIP BREAKING PROCESS IN TURNING NICKEL ALLOYS

Bogdan Słodki

The paper presents a modern method for supervising phenomena in cutting zone with high speed camera monitoring system. A few selected sequences of chip forming and breakage in longitudinal turning have been presented. Workpiece material included Inconel 625 and 718. Tools recommended by Sandvik Coromant and ISCAR have been tested. Correct sequences as well as examples of anomalies in chip breakage have been depicted and discussed. An example of using the method for determining useful chipformer application area in local machining environment has been included.

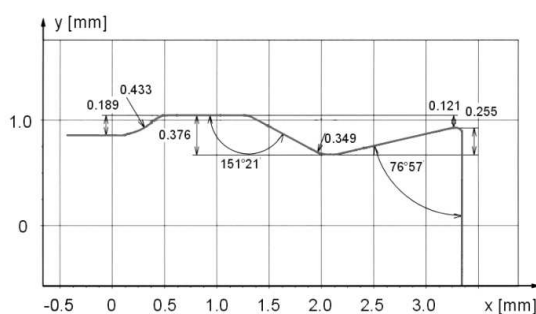
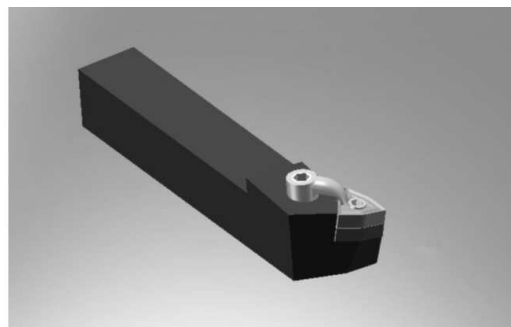
Tests were conveyed with Sandvik Coromant and ISCAR tools. Sandvik Coromant has been represented by an insert WNMG 080404-23, grade 1105 and toolholder PWLNR 2020K 08, entering angle 95° . Fig. 1 shows the tool and cross section of -23 chipformer. Recommended application area included depth of cut $a_p = 0,5 - 4,0$ mm, feed $f_n = 0,1 - 0,3$ mm/rev.

Fig.1. 3-D model of Sandvik Coromant tool and -23 chipformer cross section

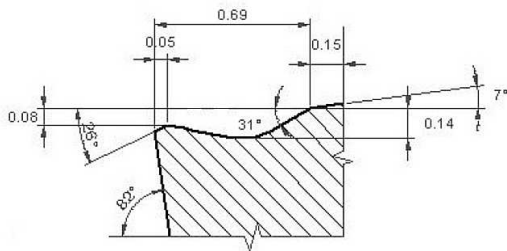
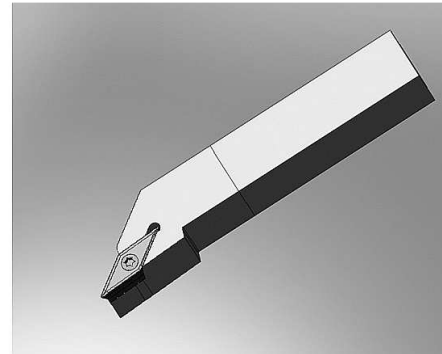
ISCAR recommends for nickel alloy turning an insert VCMT 160404 with -SM chipformer geometry, grade IC 907 coated with TiAlN layer (Fig. 2) Chipformer recommended application area: $a_p = 0,5 - 2,5$ mm, $f_n = 0,05 - 0,25$ mm/rev.

Fig. 2. 3-D model of ISCAR tool and -SM chipformer cross section

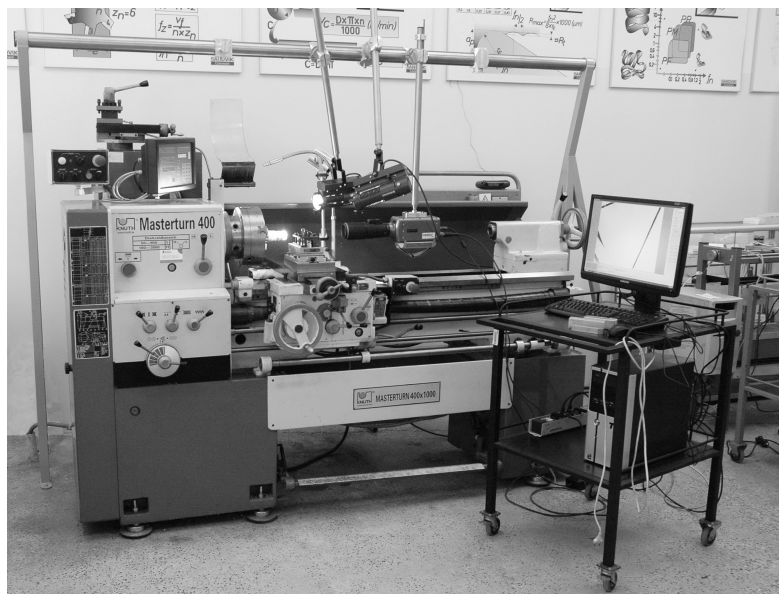
All tests have been performed on a specially prepared test stand [1]. The stand (Fig. 3) has consisted of:

1. High speed camera Phantom V5.2
2. Lens Nikkor AF Micro 200 mm f/4D IF-ED
3. Various lighting systems
4. Cine Viewer computer program for recording and picture processing
5. Precision lathe for testing tools and work materials

Fig. 3. Test stand for recording phenomena in cutting zone in turning

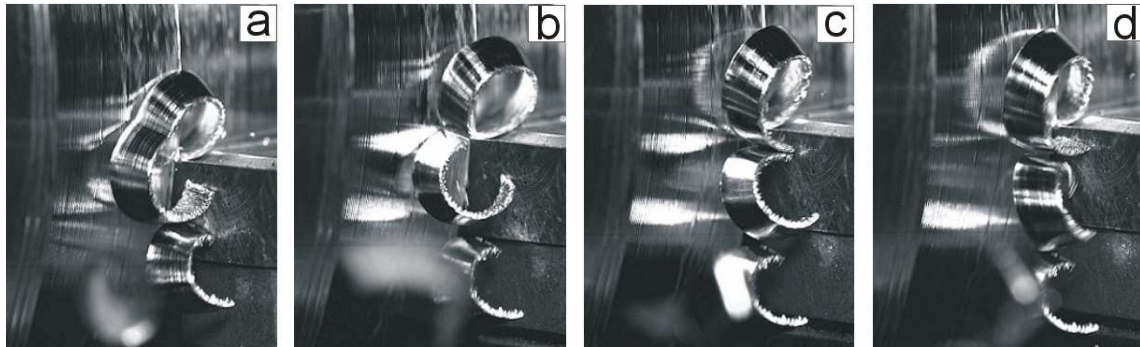
Next pictures depict selected examples of correct cycles of chip breakage. Fig. 4 shows the correct if not perfect sequence of chip breaking by hitting flank surface of the tool. Created chips are correct, short and flowing in feed direction.

Fig. 4. Correct chip breaking sequence: Inconel 718, $v_c=75$ m/min, $f_n = 0,211$ mm/rev, $a_p = 2,0$ mm, chipformer -23 recording 1000 fps, period between frames a) and f) was is 6ms, c) chip brakes and separates after hitting the flank face

Although for the individual sets of cutting data, correct chip form is achieved (Fig. 4 and 5), it does not mean that such a form will be for the whole range of cutting data recommended for particular chipformer. Fig. 10 shows examples of two chipformers useful application areas in local machining environment. In each case recorded chips have been classified into correct (+), acceptable (0) and incorrect groups. Fig 10a presents useful application area for -23 chipformer in turning Inconel 718, Fig. 10b presents useful application area for the same chipformer in turning Inconel 625.

In the example shown in Fig. 4, the chip breaking frequency was about 40 Hz. It shows how difficult is to control this process in actual machining time. The algorithms concerning cutting data selection and testing can be helpful since the local machining environment [5] [6] has significant influence on actual chipformers application areas.

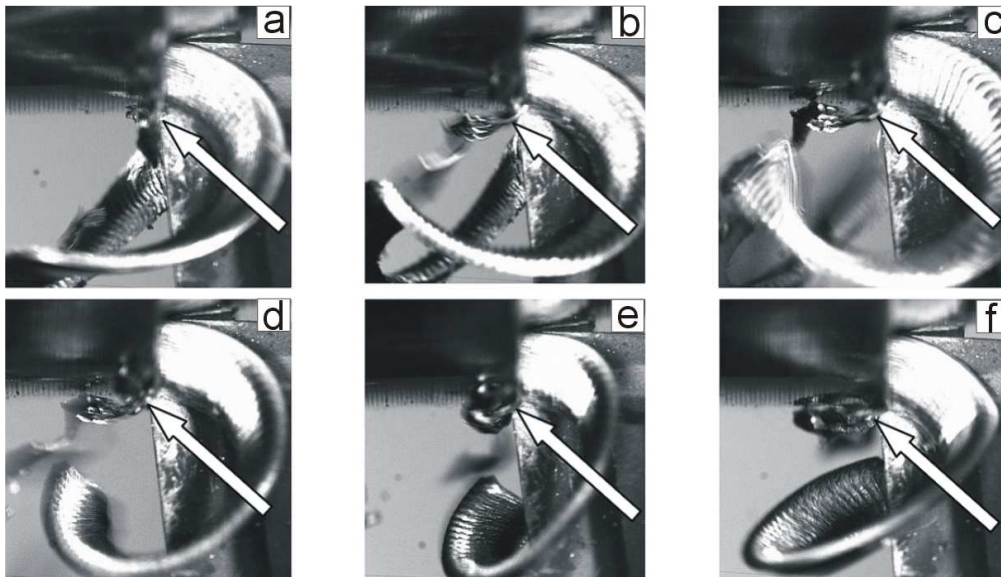
Another example presents the sequence of chipbreaking in turning Inconel 625. It has been recorded from the rake face direction (Fig. 5). Generally the process of chipbreaking is correct, but there was an “additional” chip formed (pointed by the white arrow). It is assumed that this chip is created not by cutting process but by metal embossing with the insert cutting edge. This phenomenon can be the reason for increased insert notching wear which is typical of Inconel turning. Too large cutting edge radius (in presented case $r_n = 0,035$ mm) can make cutting process difficult.

Fig. 5. Sequence of correct chip breaking seen from rake face direction: Inconel 625, $v_c=75$ m/min, $f_n = 0,211$ mm/rev, $a_p = 1,5$ mm, chipformer -23, selected 6 frames out of 23, recording 3100 fps, period between frames a) and f) is 1,65 ms, white arrow points out “additional” chip created by plastic deformation

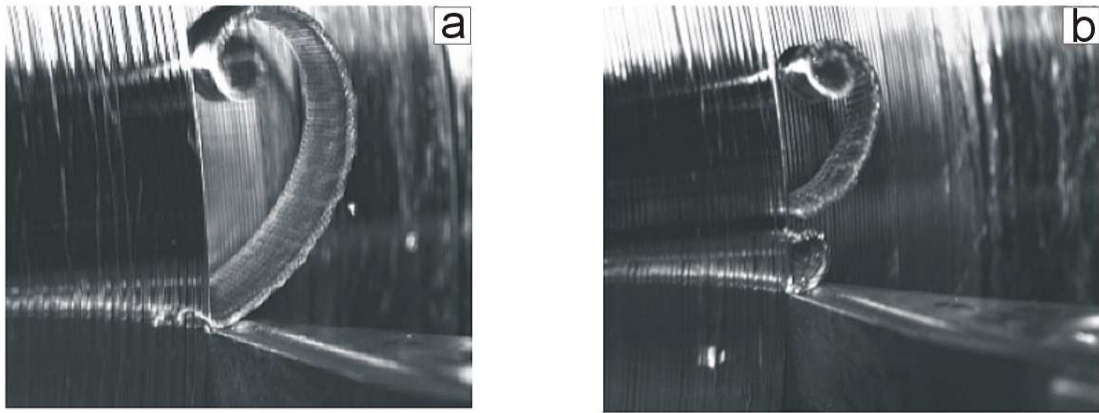
Next example shows chip breaking process by hitting raw surface of the workpiece (Fig. 6). Interesting thing is, that in spite of cyclic character of this phenomenon it can be observed that situation presented in Fig. 6a may not necessary develop in situation shown in Fig. 6b. This will be described below.

Fig. 6. Chipbreaking by hitting workpiece raw surface: Inconel 625 $v_c = 65$ m/min, $a_p = 2,5$ mm, $f_n = 0,153$ mm/rev, chipformer –SM; a) chip hits raw surface of the workpiece and bends back, b) bending strength is exceeded and the chip splits

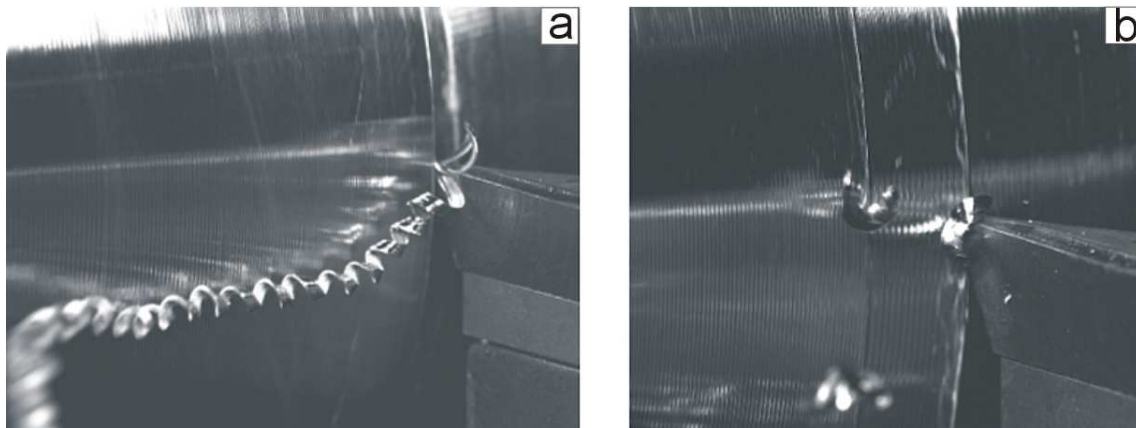
Despite the fact that in some recommended by tool manufactures application areas chip breaking process is correct, a lot of anomalies can be observed leading to incorrect chip form. Fig. 7 is an example of radical change of chip form caused by different values of feed.

Fig. 7. Example of incorrect chip form, Inconel 625, $v_c = 65$ m/min, $a_p = 0,5$ mm, $f_n = 0,077$ mm/rev, and correct form for the same cutting speed and depth of cut but for the feed $f_n = 0,249$ mm/rev, recording 1000 fps, a) incorrect chip form, b) correct chip form,

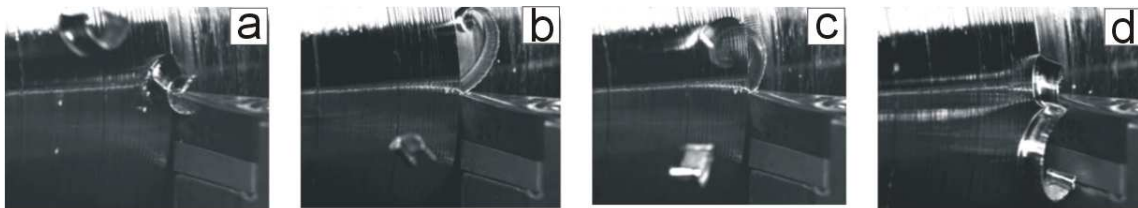
Two ways of chipbreaking in one cut has also been observed. In Fig. 8 there are examples of chipbreaking cycles under the following cutting conditions: $v_c = 65$ m/min,

$a_p = 2,5$ mm, $f_n = 0,153$ mm/rev. Chips were formed by hitting workpiece raw surface or by hitting flank surface of a tool. Sometimes, although the beginning of breaking cycle seemed to end with hitting workpiece raw surface (Fig. 8b) it actually ended with hitting flank surface of a tool (Fig. 8d). It was random process.

Fig. 8. Two kinds of chip breaking way in one cut, Inconel 625 $v_c = 65$ m/min, $a_p = 2,5$ mm, $f_n = 0,153$ mm/rev, chipformer -SM, recording 1000 fps, a) end of breaking cycle, b) chip hits the raw surface of the workpiece and bends back, c) suddenly chip slips to the left, d) breaking process ends by hitting flank surface of the insert

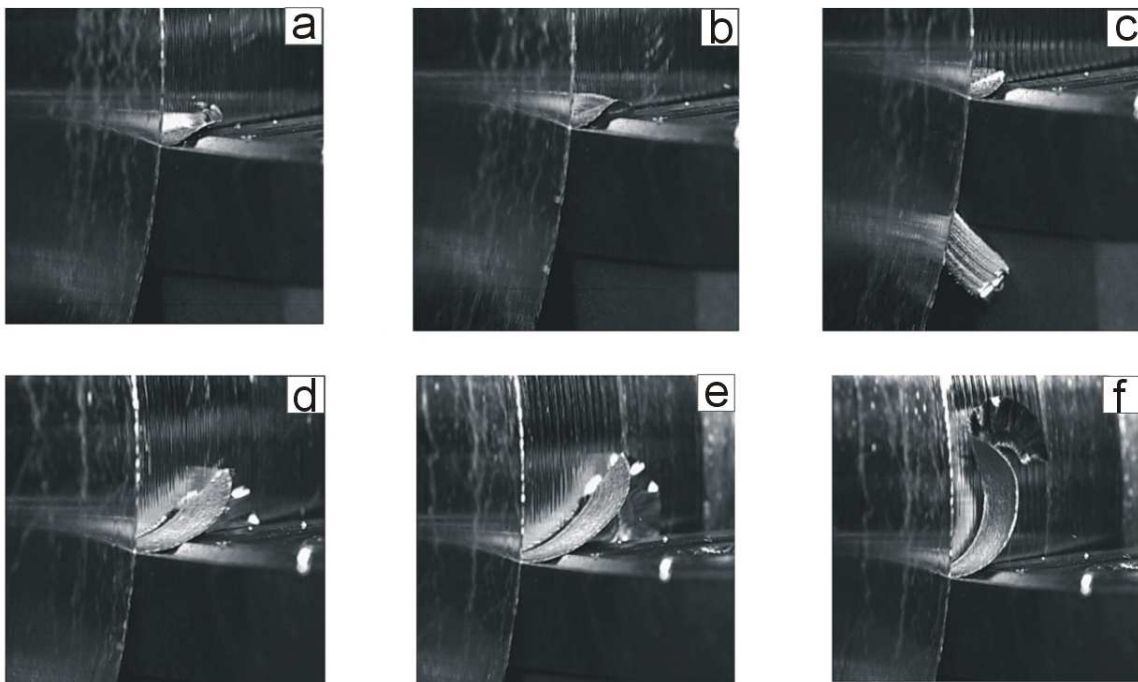
An atypical phenomenon is presented in Fig. 9. Despite the fact that cutting data followed the recommendations of tool manufacturer, incorrect chip form has been achieved. The chip bent in minor flank face direction and was out of control. Probably, when the tool began the cut, the chip groove was not filled enough to force the chip to move in the correct direction. Chips like this can destroy machined surface easily.

Fig. 9. Example of the lack of control over chip forming in Inconel 718 turning $v_c = 50$ m/min, $a_p = 2,0$ mm, $f_n = 0,211$ mm/rev, chipformer -23, recording rate 1000 fps, period between a) and f) is 79 ms, selection of 6 frames out of 79

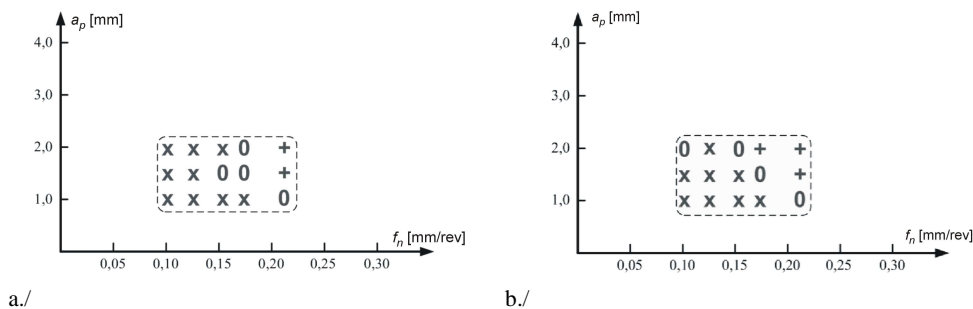
Fig. 10. Useful areas of chipformer -23 application in turning: a) Inconel 718 and b) Inconel 625
